## Asbestos Re-inspection Report

The Arcade  
Bognor Regis  
West Sussex  
PO21 1LL

Reference: C-19506

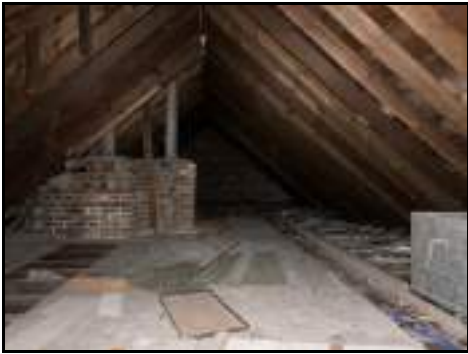
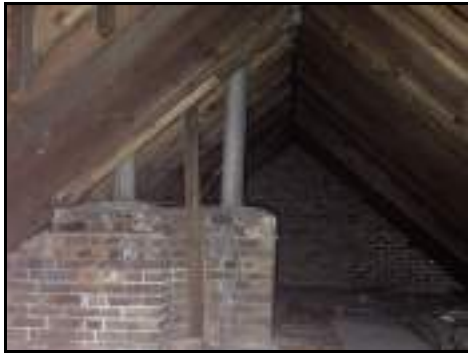
Building:	The Arcade	Floor	2nd Floor
Location ID	001	Location	Roof Void
Sample Number	PS001	Extent	<2 lin m
External Sample Ref			
Item / Position	Flues	Material	Cement Product
Product Type	Asbestos reinforced composites etc.	Scores	1
Condition	Good Condition		0
Surface Treatment	Self Sealed		0
Asbestos Type	<b>Chrysotile</b>		1
Material Assessment	Very Low		2
Substrate	Bonded to concrete	Accessibility	Low
<b>Main Photo</b>		<b>Close Up Photo</b>

Recommendation	<p><b>Remove - NON-Licensed Material Removal by an asbestos contractor. This material is not licensed however may still be notifiable to the HSE prior to removal works taking place. All works must conform to the Control of Asbestos Regulations 2012.</b></p>		
Comments	Bonded to concrete

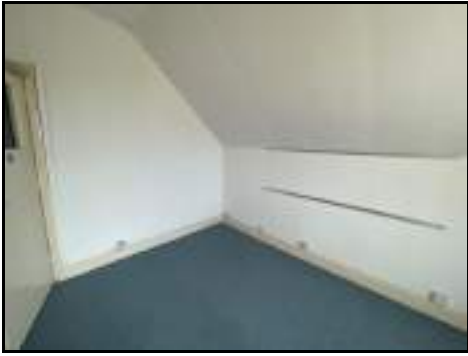
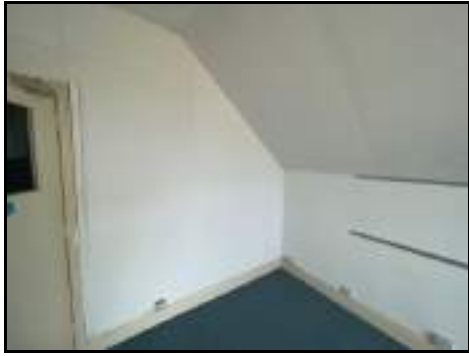
Building:	The Arcade	Floor	2nd Floor
Location ID	009	Location	Room 201
Sample Number	PS003	Extent	<10 m <sup>2</sup>
External Sample Ref			
Item / Position	Wall Cladding	Material	Insulating Board
Product Type	Asbestos insulating board, millboards, gaskets & ropes etc.	Scores	2
Condition	Good Condition		0
Surface Treatment	Sealed		1
Asbestos Type	<b>Amosite</b>		2
Material Assessment	Low		5
Substrate	nailed to timber	Accessibility	High
<b>Main Photo</b>		<b>Close Up Photo</b>

Recommendation	<b>Remove - Licensed Material Removal by a licensed asbestos contractor. This material is licensed therefore is subject to a 14 notification to the HSE prior to removal works taking place. All works must conform to the Control of Asbestos Regulations 2012.</b>		
Comments	nailed to timber

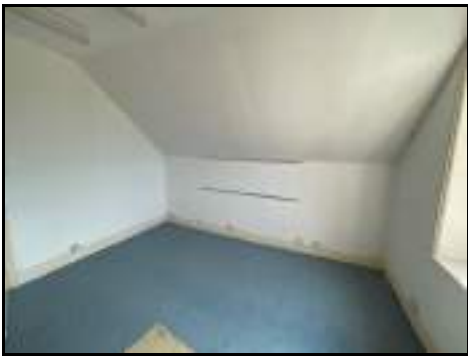
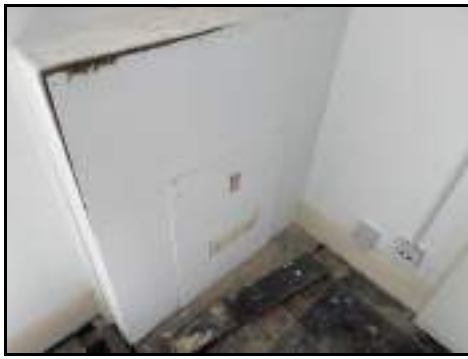
Building:	The Arcade	Floor	2nd Floor
Location ID	010	Location	Room 201
Sample Number	PS004	Extent	1 < m <sup>2</sup>
External Sample Ref			
Item / Position	infill board	Material	Insulating Board
Product Type	Asbestos insulating board, millboards, gaskets & ropes etc.	Scores	2
Condition	Good Condition		0
Surface Treatment	Sealed		1
Asbestos Type	<b>Amosite</b>		2
Material Assessment	Low		5
Substrate	screwed to timber	Accessibility	High
<b>Main Photo</b>		<b>Close Up Photo</b>

Recommendation	<p><b>Remove - Licensed Material Removal by a licensed asbestos contractor. This material is licensed therefore is subject to a 14 notification to the HSE prior to removal works taking place. All works must conform to the Control of Asbestos Regulations 2012.</b></p>		
Comments	screwed to timber

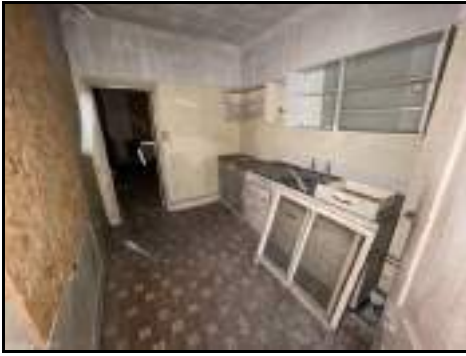
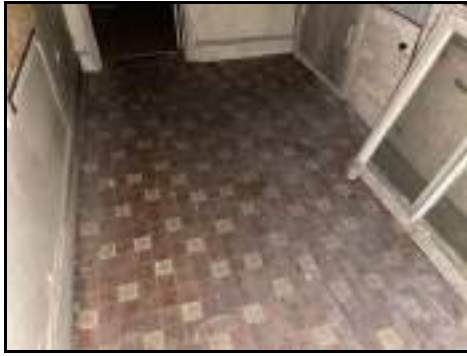
Building:	The Arcade	Floor	2nd Floor
Location ID	026	Location	Room 2
Sample Number	PS007	Extent	<10 m <sup>2</sup>
External Sample Ref			
Item / Position	Paperlined Vinyl	Material	Paper Product
Product Type	Asbestos insulating board, millboards, gaskets & ropes etc.	Scores	2
Condition	Low Damage		1
Surface Treatment	Partially Unsealed		2
Asbestos Type	<b>Chrysotile</b>		1
Material Assessment	Low		6
Substrate	Bonded to timber	Accessibility	Low
<b>Main Photo</b>		<b>Close Up Photo</b>

Recommendation	<p><b>Remove - NON-Licensed Material Removal by an asbestos contractor. This material is not licensed however may still be notifiable to the HSE prior to removal works taking place. All works must conform to the Control of Asbestos Regulations 2012.</b></p>		
Comments	<p>no suspect materials found in fireplace, polystyrene ceiling tiles                  Bonded to timber</p>

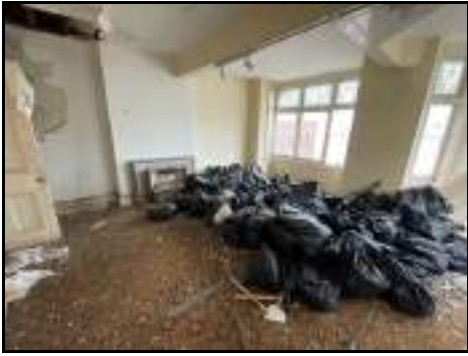
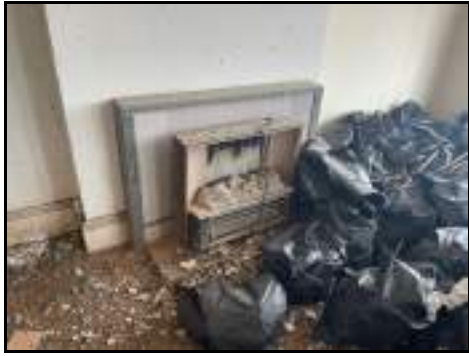
Building:	The Arcade	Floor	2nd Floor
Location ID	032	Location	Room 7
Sample Number	SP	Extent	<1 m <sup>2</sup>
External Sample Ref			
Item / Position	Fireplace	Material	Gaskets (rope/woven)
Product Type	Asbestos insulating board, millboards, gaskets & ropes etc.	Scores	2
Condition	Good Condition		0
Surface Treatment	Partially Unsealed		2
Asbestos Type	<b>Strongly Presumed Chrysotile</b>		1
Material Assessment	Low		5
Substrate	Bonded to concrete	Accessibility	Low
<b>Main Photo</b>		<b>Close Up Photo</b>

Recommendation	<b>Inaccessible Items / Strongly Presumed Inaccessible item. Isolation, access and sampling will be required prior to any works which may disturb the presumed item.</b>		
Comments	Bonded to concrete

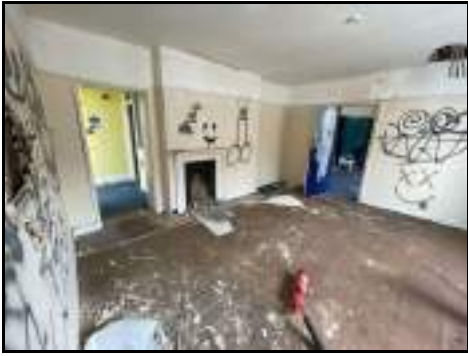
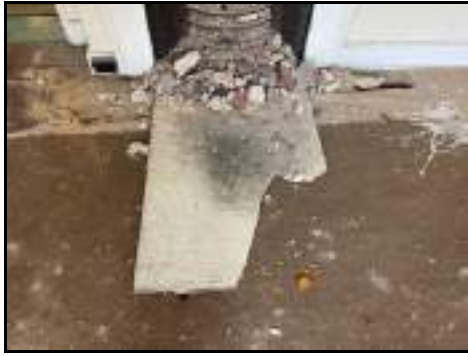
Building:	The Arcade	Floor	2nd Floor
Location ID	042	Location	Bedroom 1 &2
Sample Number	PS011	Extent	2< m <sup>2</sup>
External Sample Ref			
Item / Position	Fireplace	Material	Insulating Board
Product Type	Asbestos insulating board, millboards, gaskets & ropes etc.	Scores	2
Condition	High Damage		3
Surface Treatment	Partially Unsealed		2
Asbestos Type	<b>Chrysotile</b>		1
Material Assessment	Medium		8
Substrate	screwed timber	Accessibility	High
<b>Main Photo</b>		<b>Close Up Photo</b>

Recommendation	<b>Remove - Licensed Material Removal by a licensed asbestos contractor. This material is licensed therefore is subject to a 14 notification to the HSE prior to removal works taking place. All works must conform to the Control of Asbestos Regulations 2012.</b>		
Comments	modern skylight, modern electrics screwed timber

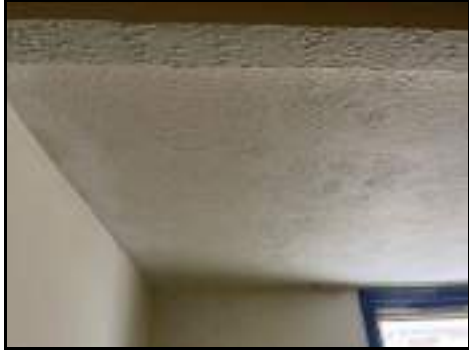
Building:	The Arcade	Floor	2nd Floor
Location ID	043	Location	Living Room
Sample Number	PS012	Extent	<16 m <sup>2</sup>
External Sample Ref			
Item / Position	Ceiling	Material	Textured Coating
Product Type	Asbestos reinforced composites etc.	Scores	1
Condition	Good Condition		0
Surface Treatment	Sealed		1
Asbestos Type	<b>Chrysotile</b>		1
Material Assessment	Very Low		3
Substrate	bonded to plaster	Accessibility	Medium
<b>Main Photo</b>		<b>Close Up Photo</b>

Recommendation	<p><b>Remove - NON-Licensed Material Removal by an asbestos contractor. This material is not licensed however may still be notifiable to the HSE prior to removal works taking place. All works must conform to the Control of Asbestos Regulations 2012.</b></p>		
Comments	<p>entrance on to flat roof. bonded to plaster</p>

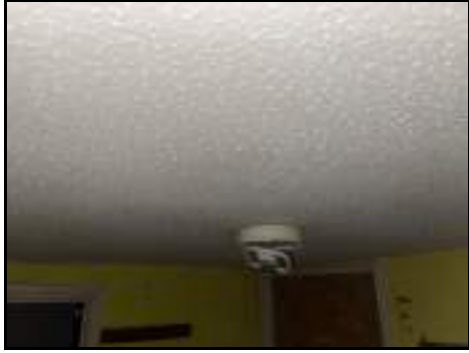
Building:	The Arcade	Floor	2nd Floor
Location ID	045	Location	kitchen/bathroom
Sample Number	PS014	Extent	<20 m <sup>2</sup>
External Sample Ref			
Item / Position	Ceiling	Material	Textured Coating
Product Type	Asbestos reinforced composites etc.	Scores	1
Condition	Good Condition		0
Surface Treatment	Sealed		1
Asbestos Type	<b>Chrysotile</b>		1
Material Assessment	Very Low		3
Substrate	Bonded to plaster	Accessibility	Medium
<b>Main Photo</b>		<b>Close Up Photo</b>

Recommendation	<p><b>Remove - NON-Licensed Material Removal by an asbestos contractor. This material is not licensed however may still be notifiable to the HSE prior to removal works taking place. All works must conform to the Control of Asbestos Regulations 2012.</b></p>		
Comments	<p>modern foam insulated boiler, unlagged pipework                  Bonded to plaster</p>

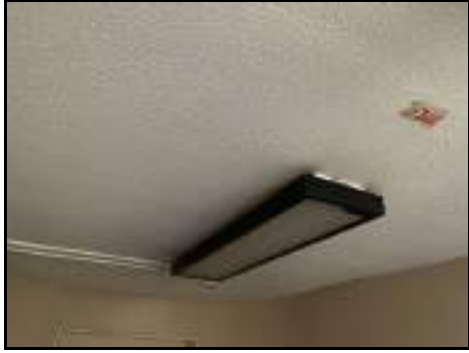
Building:	The Arcade	Floor	2nd Floor
Location ID	046	Location	Hallway
Sample Number	X014	Extent	<10 m <sup>2</sup>
External Sample Ref			
Item / Position	Ceiling	Material	Textured Coating
Product Type	Asbestos reinforced composites etc.	Scores	1
Condition	Good Condition		0
Surface Treatment	Sealed		1
Asbestos Type	<b>Chrysotile</b>		1
Material Assessment	Very Low		3
Substrate	bonded to plaster	Accessibility	Medium
<b>Main Photo</b>		<b>Close Up Photo</b>

Recommendation	<p><b>Remove - NON-Licensed Material Removal by an asbestos contractor. This material is not licensed however may still be notifiable to the HSE prior to removal works taking place. All works must conform to the Control of Asbestos Regulations 2012.</b></p>		
Comments	bonded to plaster

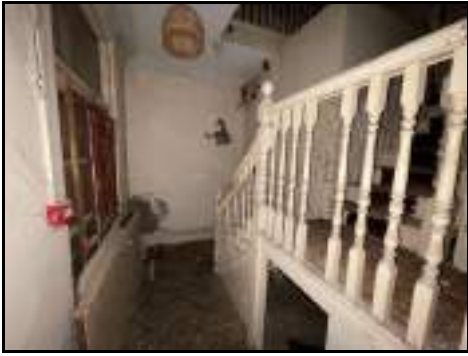
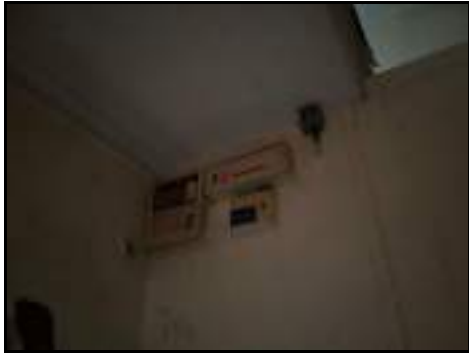
Building:	The Arcade	Floor	1st Floor
Location ID	033	Location	Stairwell Including Landing
Sample Number	SP	Extent	<1 m <sup>2</sup>
External Sample Ref			
Item / Position	Electrical Consumer Units	Material	Gaskets (rope/woven)
Product Type	Asbestos insulating board, millboards, gaskets & ropes etc.	Scores	2
Condition	Good Condition		0
Surface Treatment	Partially Unsealed		2
Asbestos Type	<b>Strongly Presumed Chrysotile</b>		1
Material Assessment	Low		5
Substrate	Bonded to metal	Accessibility	Low
<b>Main Photo</b>		<b>Close Up Photo</b>

Recommendation	<b>Inaccessible Items / Strongly Presumed Inaccessible item. Isolation, access and sampling will be required prior to any works which may disturb the presumed item.</b>		
Comments	Bonded to metal

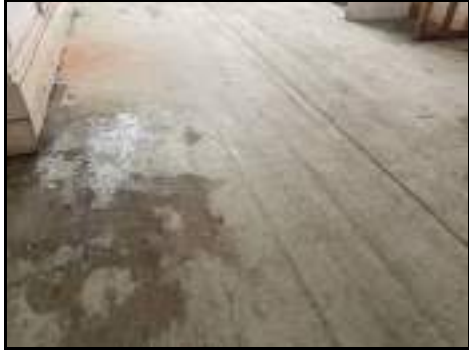
Building:	The Arcade	Floor	1st Floor
Location ID	034	Location	Room 8
Sample Number	PS009	Extent	<54 m <sup>2</sup>
External Sample Ref			
Item / Position	Floor Covering	Material	Vinyl Products
Product Type	Asbestos reinforced composites etc.	Scores	1
Condition	Good Condition		0
Surface Treatment	Self Sealed		0
Asbestos Type	<b>Chrysotile</b>		1
Material Assessment	Very Low		2
Substrate	Bonded to timber	Accessibility	Low
<b>Main Photo</b>		<b>Close Up Photo</b>

Recommendation	<p><b>Remove - NON-Licensed Material Removal by an asbestos contractor. This material is not licensed however may still be notifiable to the HSE prior to removal works taking place. All works must conform to the Control of Asbestos Regulations 2012.</b></p>		
Comments	<p>Bonded to timber</p>

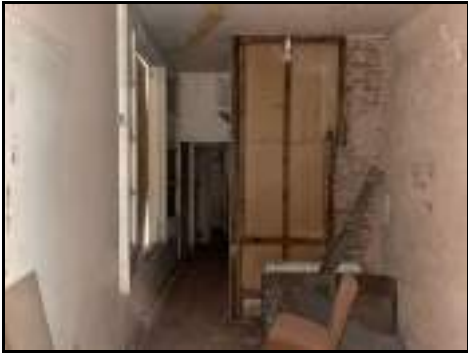
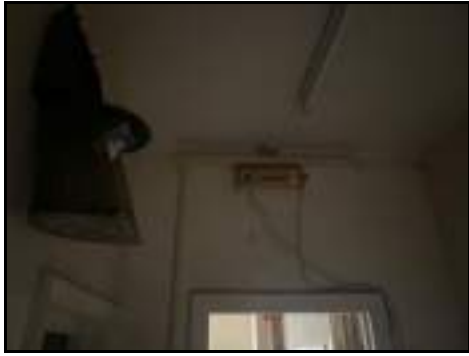
Building:	The Arcade	Floor	1st Floor
Location ID	035	Location	Hallway
Sample Number	SP	Extent	<1 m <sup>2</sup>
External Sample Ref			
Item / Position	Electrical Consumer Units	Material	Gaskets (rope/woven)
Product Type	Asbestos insulating board, millboards, gaskets & ropes etc.	Scores	2
Condition	Good Condition		0
Surface Treatment	Partially Unsealed		2
Asbestos Type	<b>Strongly Presumed Chrysotile</b>		1
Material Assessment	Low		5
Substrate	Bonded to metal	Accessibility	Low
<b>Main Photo</b>		<b>Close Up Photo</b>

Recommendation	<b>Inaccessible Items / Strongly Presumed Inaccessible item. Isolation, access and sampling will be required prior to any works which may disturb the presumed item.</b>		
Comments	Bonded to metal

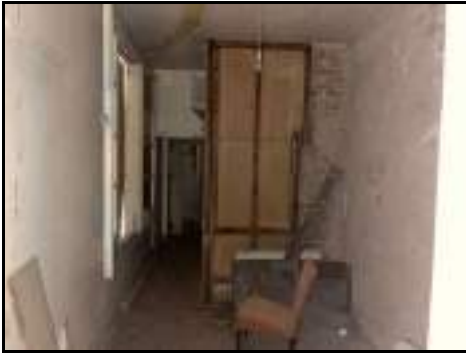
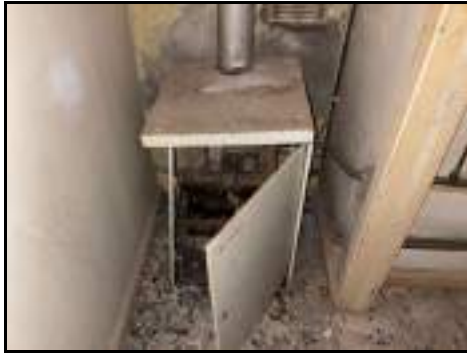
Building:	The Arcade	Floor	1st Floor
Location ID	036	Location	Rooms 9,10,11
Sample Number	SP	Extent	<1 m <sup>2</sup>
External Sample Ref			
Item / Position	Electrical Consumer Units	Material	Gaskets (rope/woven)
Product Type	Asbestos insulating board, millboards, gaskets & ropes etc.	Scores	2
Condition	Good Condition		0
Surface Treatment	Partially Unsealed		2
Asbestos Type	<b>Strongly Presumed Chrysotile</b>		1
Material Assessment	Low		5
Substrate	Bonded to metal	Accessibility	Low
<b>Main Photo</b>		<b>Close Up Photo</b>

Recommendation	<b>Inaccessible Items / Strongly Presumed Inaccessible item. Isolation, access and sampling will be required prior to any works which may disturb the presumed item.</b>		
Comments	Bonded to metal

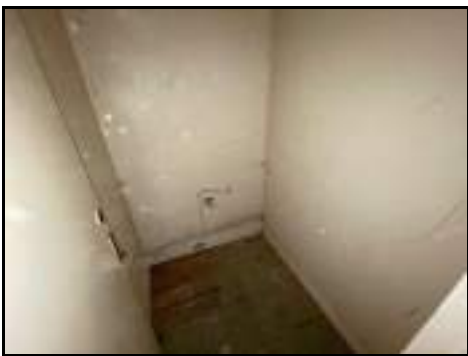
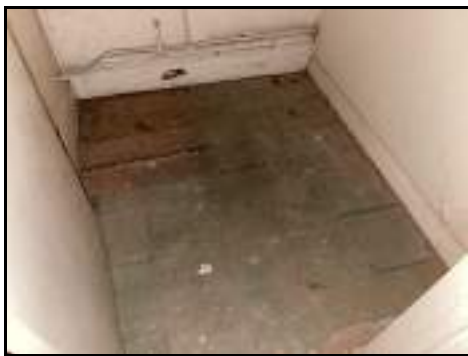
Building:	The Arcade	Floor	1st Floor
Location ID	036	Location	Rooms 9,10,11
Sample Number	X009	Extent	<5 m <sup>2</sup>
External Sample Ref			
Item / Position	Floor Covering	Material	Vinyl Products
Product Type	Asbestos reinforced composites etc.	Scores	1
Condition	Good Condition		0
Surface Treatment	Self Sealed		0
Asbestos Type	<b>Chrysotile</b>		1
Material Assessment	Very Low		2
Substrate	Bonded to timber	Accessibility	Low
<b>Main Photo</b>		<b>Close Up Photo</b>

Recommendation	<p><b>Remove - NON-Licensed Material Removal by an asbestos contractor. This material is not licensed however may still be notifiable to the HSE prior to removal works taking place. All works must conform to the Control of Asbestos Regulations 2012.</b></p>		
Comments	<p>Bonded to timber</p>

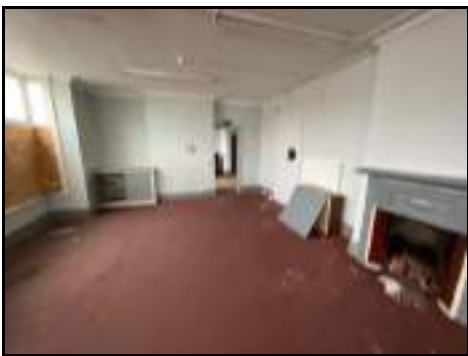
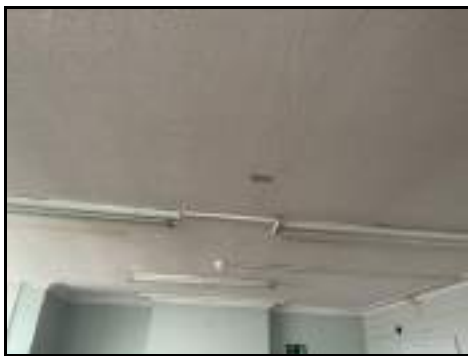
Building:	The Arcade	Floor	1st Floor
Location ID	048	Location	Room 14 B
Sample Number	PS016	Extent	<30 m <sup>2</sup>
External Sample Ref			
Item / Position	Ceiling	Material	Textured Coating
Product Type	Asbestos reinforced composites etc.	Scores	1
Condition	Good Condition		0
Surface Treatment	Sealed		1
Asbestos Type	<b>Chrysotile</b>		1
Material Assessment	Very Low		3
Substrate	bonded to plaster	Accessibility	
<b>Main Photo</b>		<b>Close Up Photo</b>

Recommendation	<p><b>Remove - NON-Licensed Material Removal by an asbestos contractor. This material is not licensed however may still be notifiable to the HSE prior to removal works taking place. All works must conform to the Control of Asbestos Regulations 2012.</b></p>		
Comments	<p>no suspect items found in fireplace bonded to plaster</p>

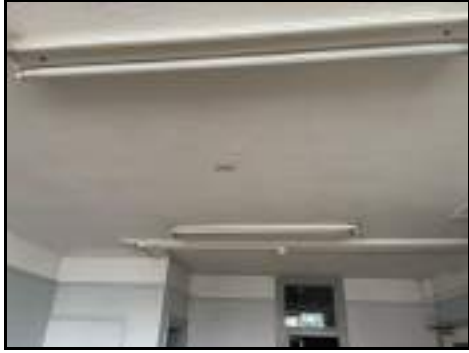
Building:	The Arcade	Floor	1st Floor
Location ID	049	Location	Room 13
Sample Number	X016	Extent	<25 m <sup>2</sup>
External Sample Ref			
Item / Position	Ceiling	Material	Textured Coating
Product Type	Asbestos reinforced composites etc.	Scores	1
Condition	Good Condition		0
Surface Treatment	Sealed		1
Asbestos Type	<b>Chrysotile</b>		1
Material Assessment	Very Low		3
Substrate	bonded to plaster	Accessibility	Medium
<b>Main Photo</b>		<b>Close Up Photo</b>

Recommendation	<p><b>Remove - NON-Licensed Material Removal by an asbestos contractor. This material is not licensed however may still be notifiable to the HSE prior to removal works taking place. All works must conform to the Control of Asbestos Regulations 2012.</b></p>		
Comments	bonded to plaster

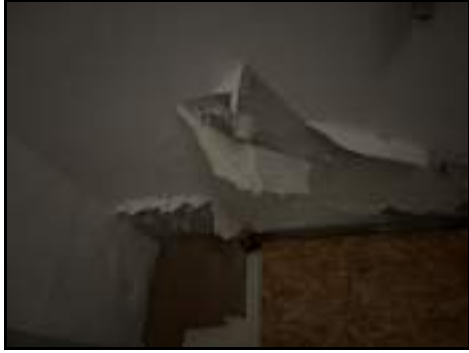
Building:	The Arcade	Floor	1st Floor
Location ID	050	Location	Room 13a
Sample Number	X016	Extent	<33 m <sup>2</sup>
External Sample Ref			
Item / Position	Ceiling and Walls	Material	Textured Coating
Product Type	Asbestos reinforced composites etc.	Scores	1
Condition	Low Damage		1
Surface Treatment	Sealed		1
Asbestos Type	<b>Chrysotile</b>		1
Material Assessment	Very Low		4
Substrate	bonded to plaster	Accessibility	Medium
<b>Main Photo</b>		<b>Close Up Photo</b>

Recommendation	<p><b>Restrict access and remove Removal by a licensed asbestos contractor. This material is licensed therefore is subject to a 14 notification to the HSE prior to removal works taking place. All works must conform to the Control of Asbestos Regulations 2012.</b></p>		
Comments	bonded to plaster

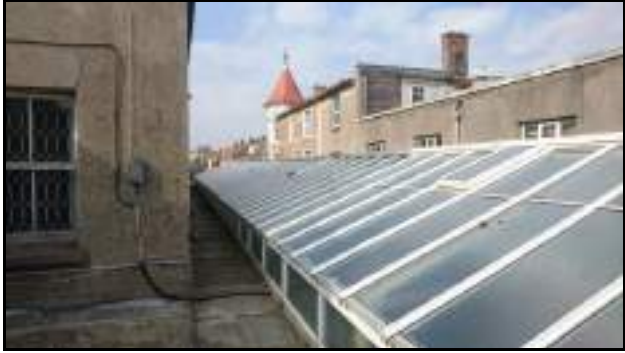
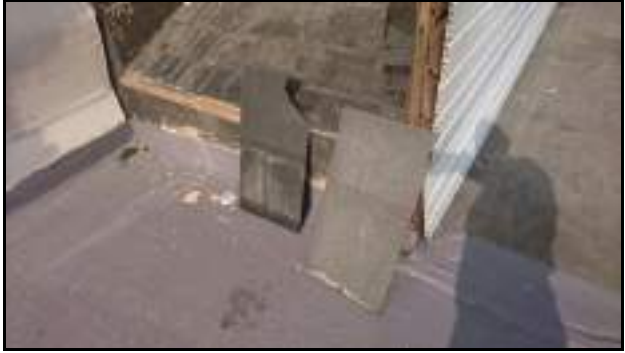
Recommendation	<b>No action required No action required.</b>		
Comments	Nailed to timber Cement debris has been removed.

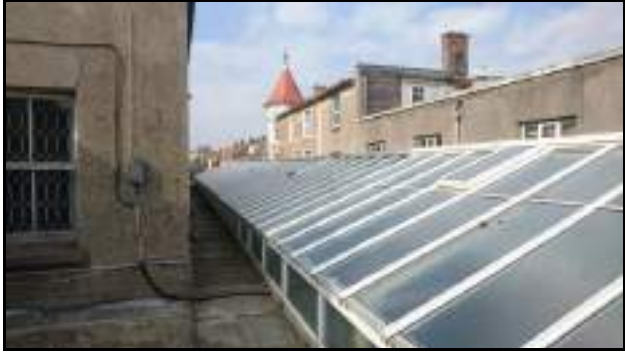
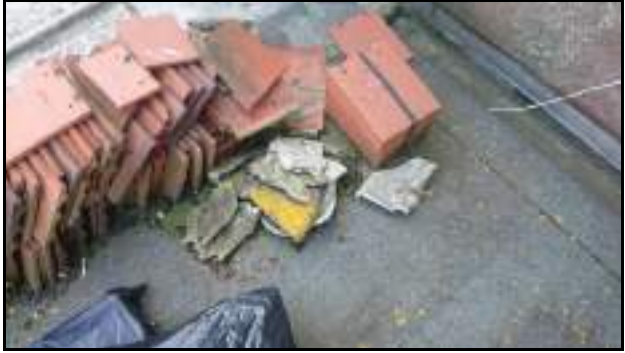
Recommendation	<b>No action required No action required.</b>		
Comments	Nailed to timber Debris has been removed.
