ROYAL HALL, BOGNOR REGIS
FEASIBILITY REPORT
ARUN DISTRICT COUNCIL
1st March 2024

Royal Hall Feasibility Report

5024385 – BREWERS FAYRE, BOGNOR REGIS BUILDING CONDITION REPORT

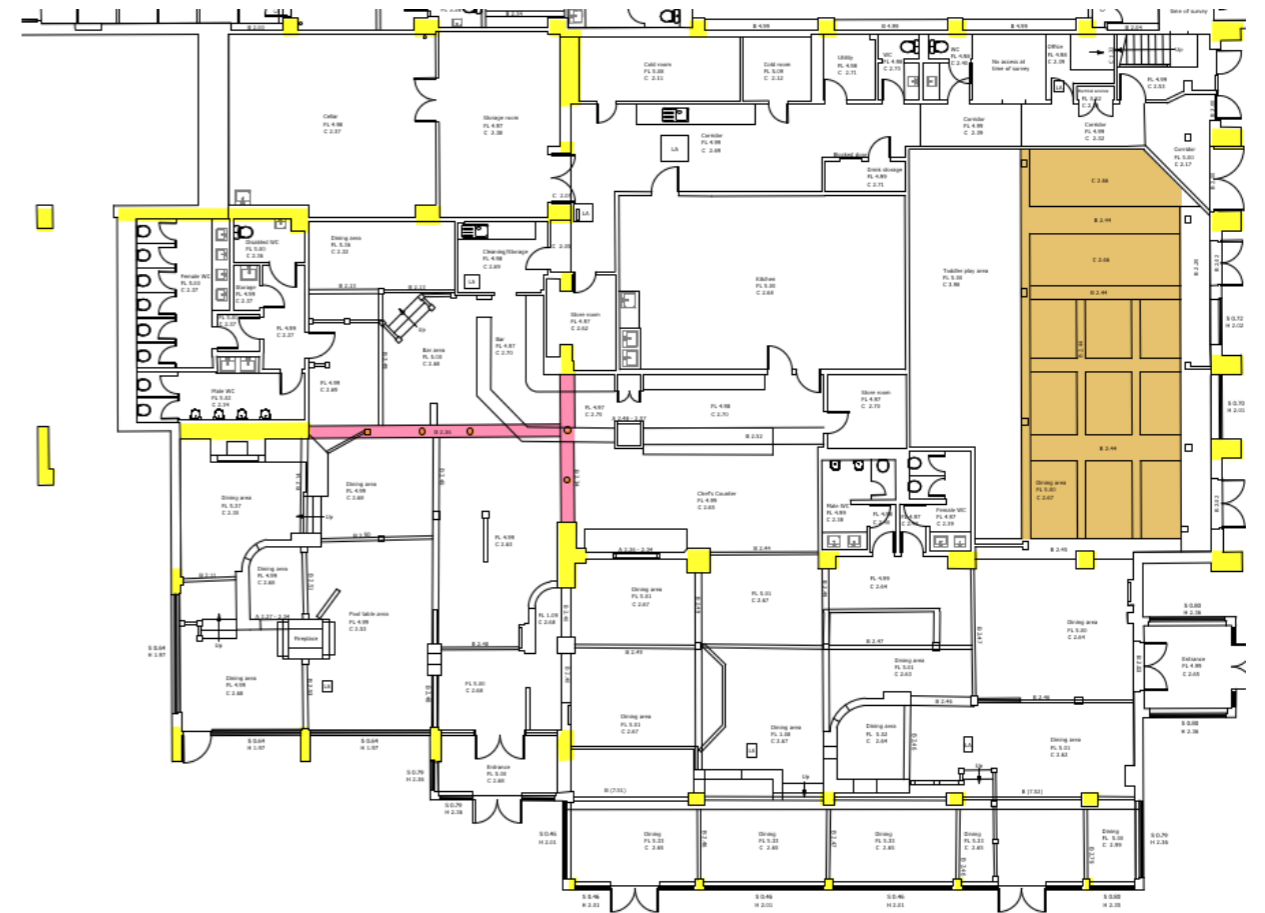
Figure 9: Existing Layout of Royal Hall Highlighting Load Bearing Elements and Structural Modifications

Moreover, a comparison between the current layout and record drawings suggests the potential removal of two load-bearing walls, replaced by steel columns (Figure 2, red area). The foundations of these columns are currently undocumented. The remaining structural elements, (Figure 2, yellow area) are in keeping with record drawings.

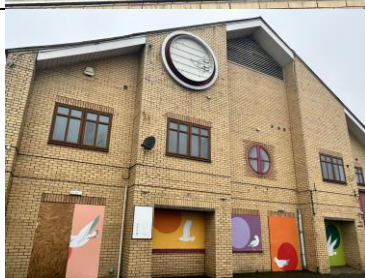
AREA	DESCRIPTION / ISSUE	CONDITION	RECOMMENDATION	PRIORITY	PHOTO REF
	Across the East elevation the brickwork appears to be in fair condition.				
Cladding	The Southeast corner of the ground floor has been overclad using a uPVC composite shiplap effect cladding. Cladding appears to be in a fair condition although it is noted that fixings to the items / services mounted across the elevation have rusted causing staining to the cladding.	2	Recommend removal of rusted fixings and replacement using suitable marine grade stainless steel fixings. Clean down staining to cladding.	2

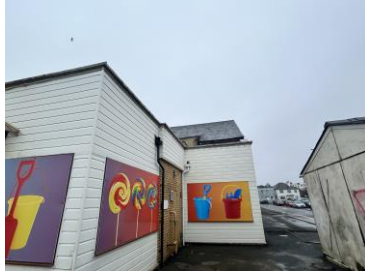
Windows – Double Glazed	uPVC double glazed casement windows at 1 st floor level. Windows appear to be in fair condition, although some double glazed units appear to have blown. Note: Windows at ground floor level have been over boarded and could not be inspected.	1	Where double glazed units have blown replacement is recommended.	1

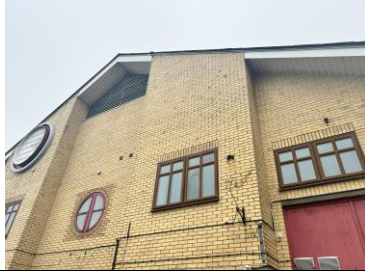
Windows – Timber	Timber double glazed circular window to 1 st floor. Timber frame appears to be in poor condition with some apparent rot. Paintwork observed to be in poor condition and flaking. Note: Windows at ground floor level have been over boarded and could not be inspected.	1	Where timber windows are rotten and defective replacement of the window is recommended.	1

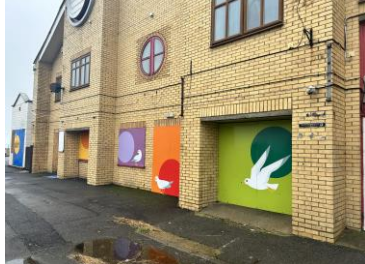
AREA	DESCRIPTION / ISSUE	CONDITION	RECOMMENDATION	PRIORITY	PHOTO REF
Doors	<p>2no. Single timber doors leading to staff access to the back of house areas within the pub, and separate access for the 1st floor staff accommodation above. Timber doors are inset within timber panels, thought to be exterior grade ply. Decoration to inset timber panels is poor.</p> <p>Condition of access door to back of house areas of the pub is fair.</p> <p>Condition of access door to staff accommodation is poor.</p> <p>Note: Doors into the restaurant front of house area have been over boarded and could not be inspected.</p>	1	<p>Recommend redecoration of timber panels surrounding doors.</p> <p>Recommend replacement of timber access doors.</p>	1

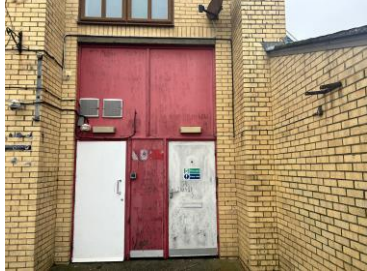
Hardstanding	<p>Tarmac hardstanding to front of elevation appears to be in fair condition. Previous patch repairs are evidence and moss growth is noted to localised areas.</p> <p>Note: It is unknown whether the hardstanding to this elevation forms part of the grounds of the property.</p>	2	<p>Recommend regular maintenance is undertaken to areas of hardstanding to remove moss growth.</p>	3

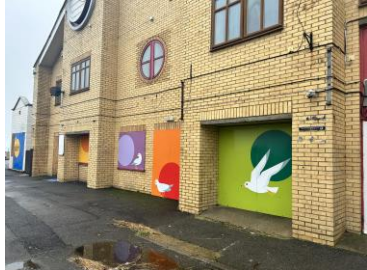
South Elevation					
Roof	<p>It appears that the roof across this elevation is a flat roof to the front elevation of the property. The rood could not be observed from ground level and no further comments have been made.</p> <p>There is a small section of low level slate roof to the Southwest corner, although the condition of this could not be observed from ground level.</p>		<p>Further inspection of the roof is recommended.</p>	1

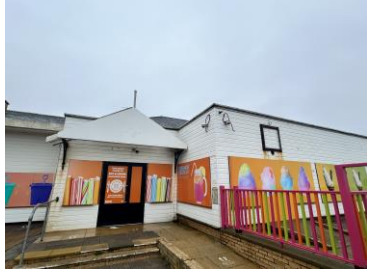
AREA	DESCRIPTION / ISSUE	CONDITION	RECOMMENDATION	PRIORITY	PHOTO REF
Soffits / Fascia	Soffits and fascia to the Southwest corner appear to be decorated timber; decoration to soffits and fascia are noted to be in poor condition.	2	Recommend redecoration of soffit and fascia. Where necessary rotten timber should be replaced.	2

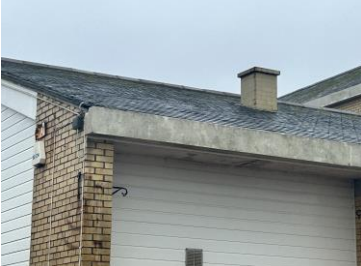
Cladding	Single storey section to South elevation has been over clad using uPVC shiplap style cladding. Across the elevation the cladding appears to be in a fair condition although it is noted that fixings to the items / services mounted across the elevation have rusted causing staining to the cladding.	2	Recommend removal of rusted fixings and replacement using suitable marine grade stainless steel fixings. Clean down staining to cladding.	2

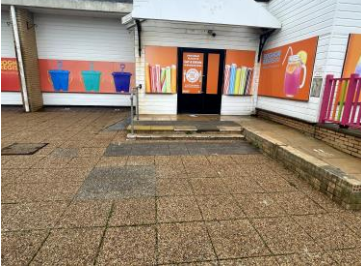
AREA	DESCRIPTION / ISSUE	CONDITION	RECOMMENDATION	PRIORITY	PHOTO REF
Hardstanding	<p>Raised paved hardstanding area to the front elevation of the property. Overall paved area appears to be in fair condition although it is noted that some paving slabs are broken.</p> <p>A low level wall separates the hardstanding from the adjacent pavement. It was observed that in some areas the capping stones appear to have been poorly cut to size with gaps evident to the corner sections.</p>	2	<p>Recommend replacement of broken or loose paving slabs.</p> <p>Recommend replacement of poorly installed corner capping stone.</p>	2

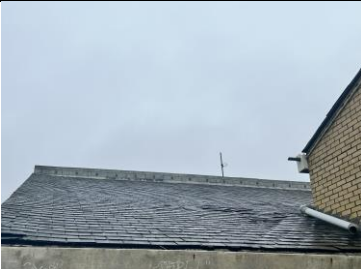
AREA	DESCRIPTION / ISSUE	CONDITION	RECOMMENDATION	PRIORITY	PHOTO REF
Fascia	Fascia is observed to be decorated timber; decoration to soffits and fascia are noted to be in poor condition.	2	Recommend redecoration of soffit and fascia. Where necessary rotten timber should be replaced.	2

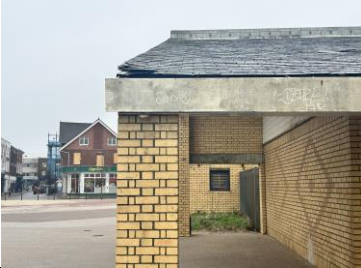
Lintel	Concrete lintel forming opening to walkway between supporting pillar and west elevation of the building. Concrete is in a poor condition and is noted to be cracked and spalling. Rust is also present to the surface of the concrete indicating the rusting of the reinforcement within the lintel.	1	Recommend review by a structural engineer.	1

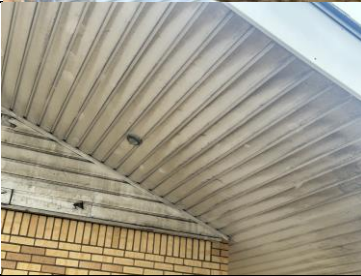
Cladding	Sections of the West elevation have been over clad using uPVC shiplap style cladding. Across the elevation the cladding appears to be in a fair condition although localised sections are noted to be damaged.	2	Recommend repair and replacement of damaged cladding.	2

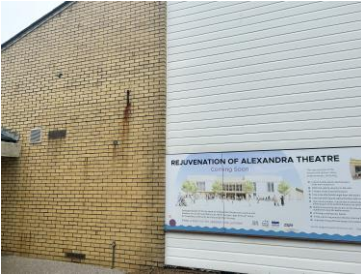
AREA	DESCRIPTION / ISSUE	CONDITION	RECOMMENDATION	PRIORITY	PHOTO REF
Brickwork	<p>The majority of the West elevation is formed of smooth cream wire cut brickwork in standard running bond. A decorative diamond patten has been inset using differing coloured bricks to the section of wall adjacent to the covered walkway.</p> <p>To the pillar supporting the section of oversailing roof to the walkway Flemish bond has been used to add detail.</p> <p>Across the West elevation the brickwork appears to be in fair condition, although localised sections of rust staining are observed to the underside of fixings to the wall.</p>	3	<p>Recommend removal of rusted fixings and replacement using suitable marine grade stainless steel fixings.</p> <p>Cleaning of staining to brickwork recommended.</p>	2

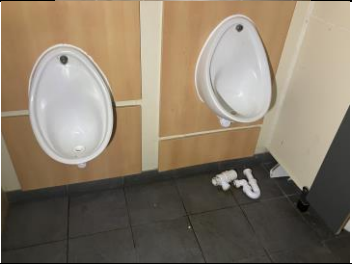
Windows	No windows to area.				
Sanitary Ware	WC has been uncoupled and pipework to the rear of the WC appears to have been damaged.	3	Recommend replacement of sanitaryware.	2

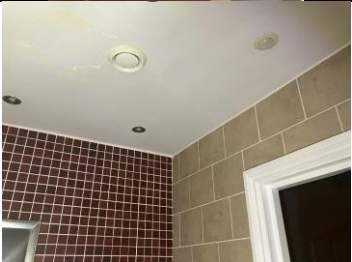
Floor	Non slip vinyl sheet flooring, appears to be in fair condition although sections noted to be lifted adjacent to door.	2	Recommend replacement of flooring.	2	
Windows	No windows to area.				
Sanitary Ware	WCs appear to have been removed from cubicles, pipe work appears damaged.	2	Recommend replacement of sanitary ware.	2

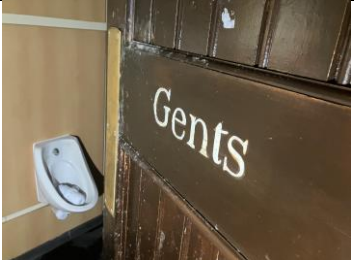
AREA	ISSUE	CONDITION	RECOMMENDATION	PRIORITY	PHOTO REF
Walls	Full height tiling to some sections, IPS boxing to rear of urinals and WCs. Some damage to IPS boxing and discolouration to low levels of grouting.	2	Recommend replacement of damaged IPS panels. Recommend renewal of grouting.	2

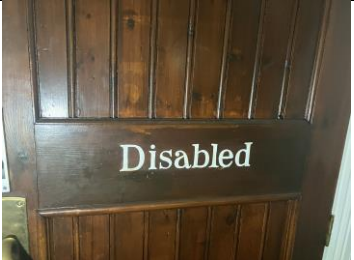
Walls	Full height tile to walls, tile broken out to low level adjacent to cistern to gain access to pipes inset in wall. Further section of damaged tile to rear of WC Cistern.	2	Recommend removal of tiles and replacement with new.	2

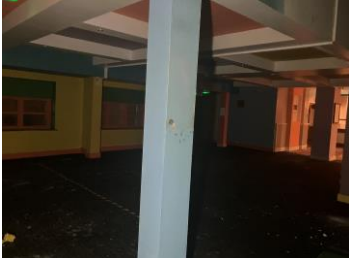
AREA	ISSUE	CONDITION	RECOMMENDATION	PRIORITY	PHOTO REF
Floor	<p>Carpet laid throughout main seating area in poor condition and noted to be covered in mould.</p> <p>Differing carpet noted to be installed to play area, carpet also in poor condition and is loose in some areas.</p>	2	Recommend removal of existing carpet throughout and replacement with new.	2
