FORESHORE RAMP SITE INVESTIGATIONS

Technical review of Arun District Council ramps to assess, inform and facilitate future development of access arrangements on the Arun coastline.

Arun District Council,
Coastal Engineers and Flood
Prevention

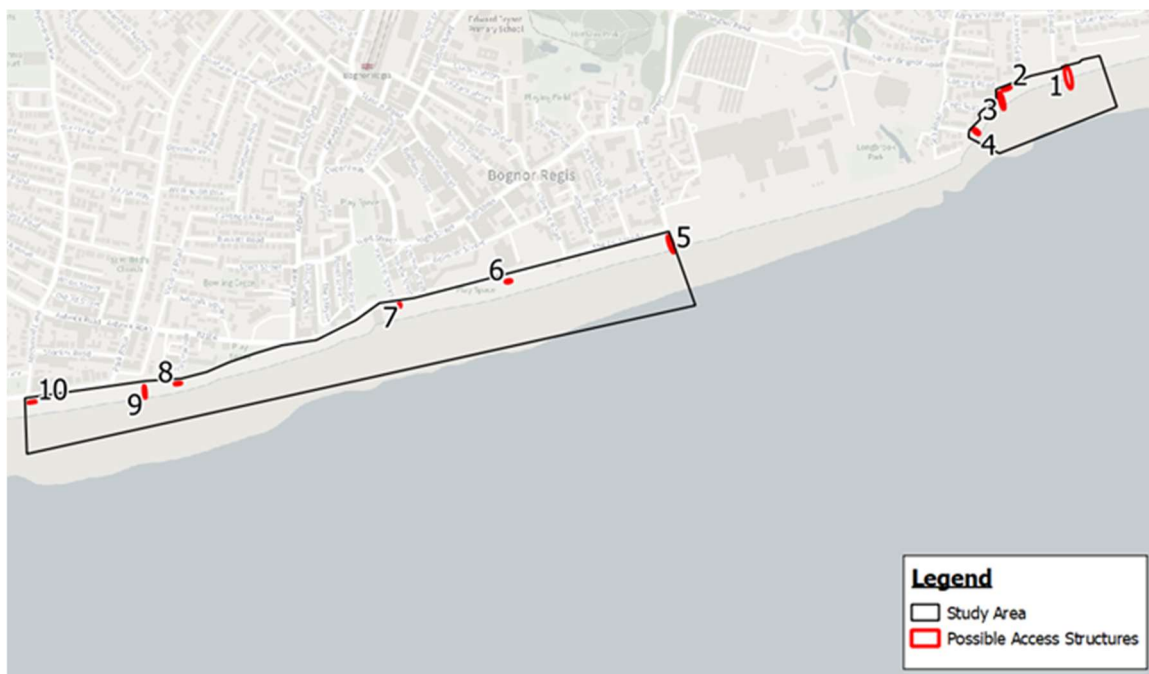
Figure 2 - Map showing where existing ramps may be present

The initial piece of work required Arun District Council Engineers to review, collate and evaluate all ramps which could potentially increase accessibility to the lower foreshore. It was concluded that the most appropriate approach was to consider all known ramps to ensure assets were not dismissed prematurely. The ramps that could play a role in facilitating beach access have been highlighted and numbered below - See Figure 2 .

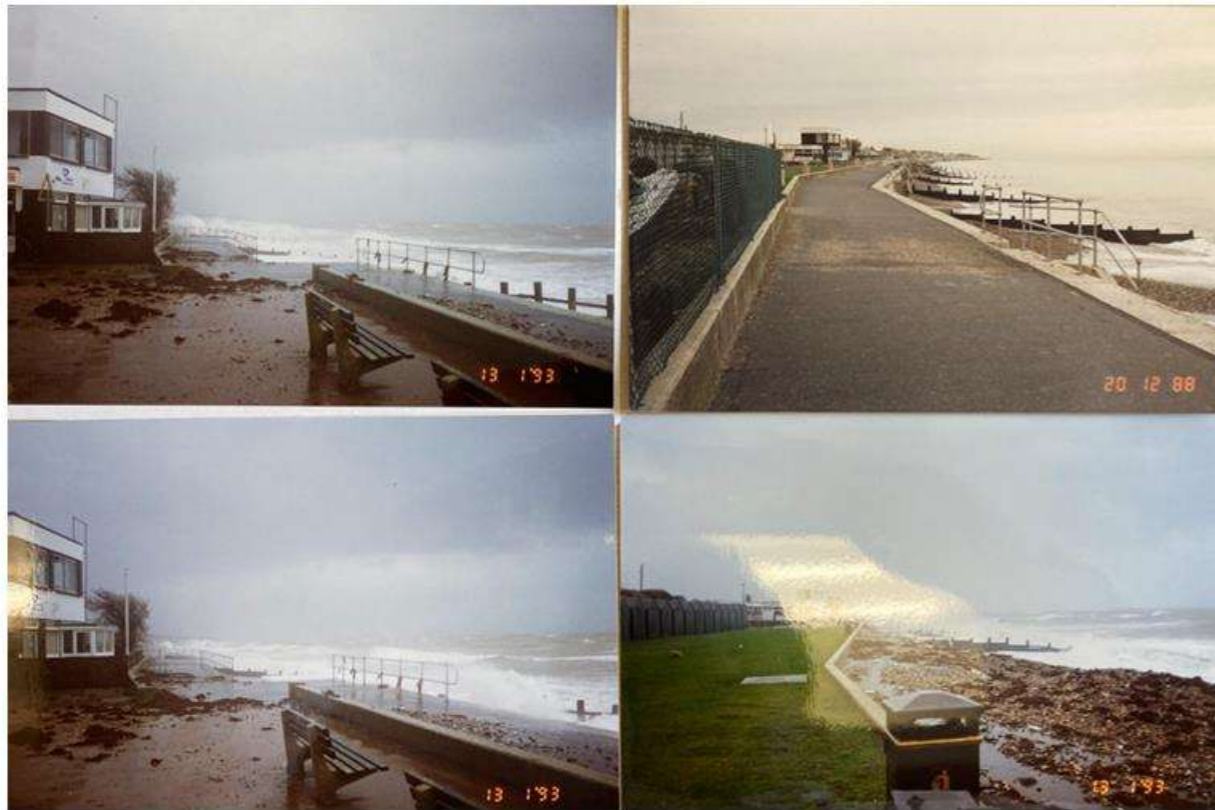
Figure 3 - Historic photographs of Blakes Road

The ramp and facilities at Blakes Road are the best offering within the study area. The ramp is generally clear with direct access to the lower foreshore and benefits from accessible parking, toilets, and a café within a 75m radius. The facilities are good quality with the toilets and carpark having been upgraded in the last 5 years. It is one of the few ramps that could foreseeably accommodate modifications, such as resting areas, to make the offering more user friendly.

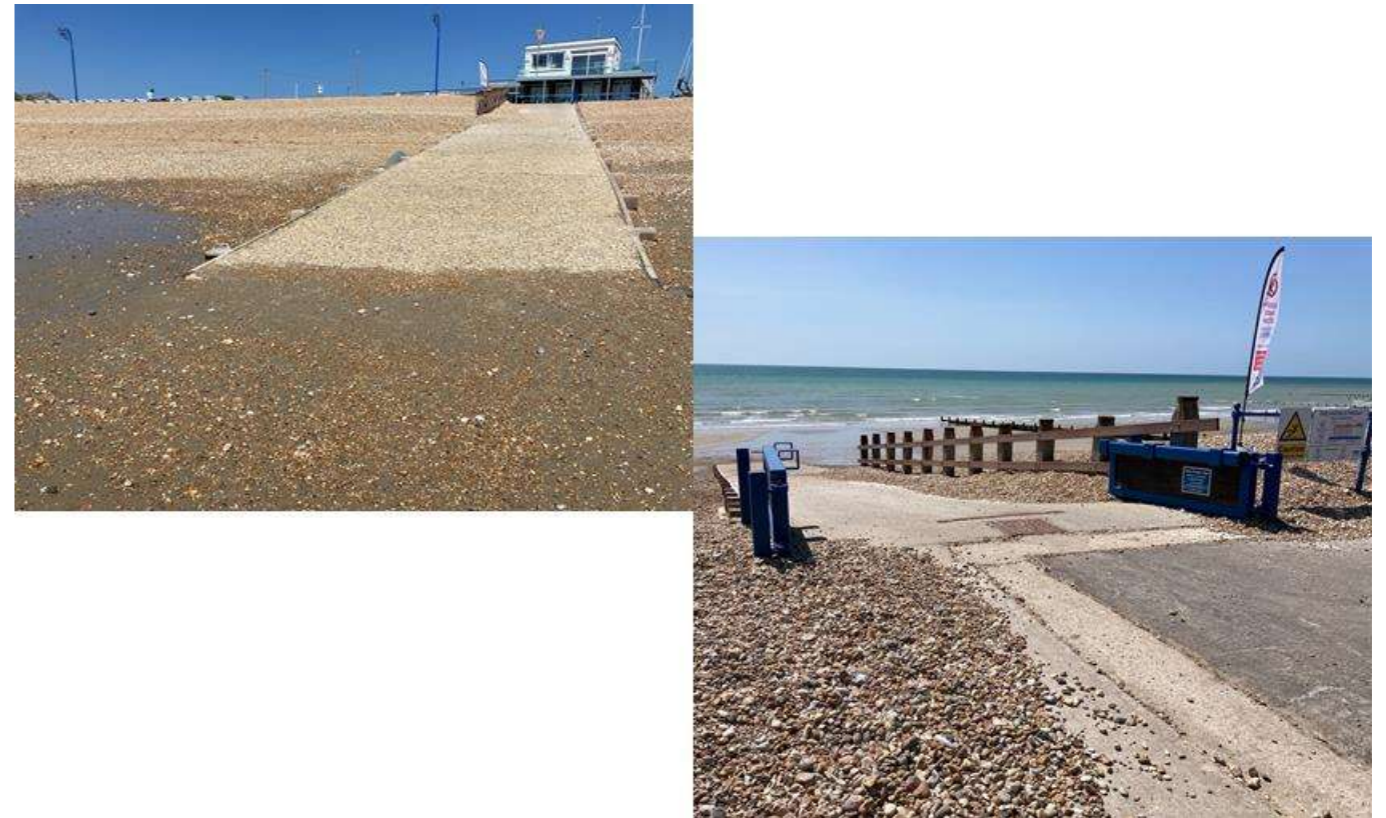
Figure 4 - Blakes Road, May 2023

The main drawback of this location is that access using public transport is limited to taxi's and buses. However, the route to the nearest bus stop is generally flat and over half of the distance (170m) is covered on the promenade. The other major consideration is that the ramp is known to be utilised by Felpham Sailing Club but through appropriate engagement it is envisaged that this can be managed appropriately.

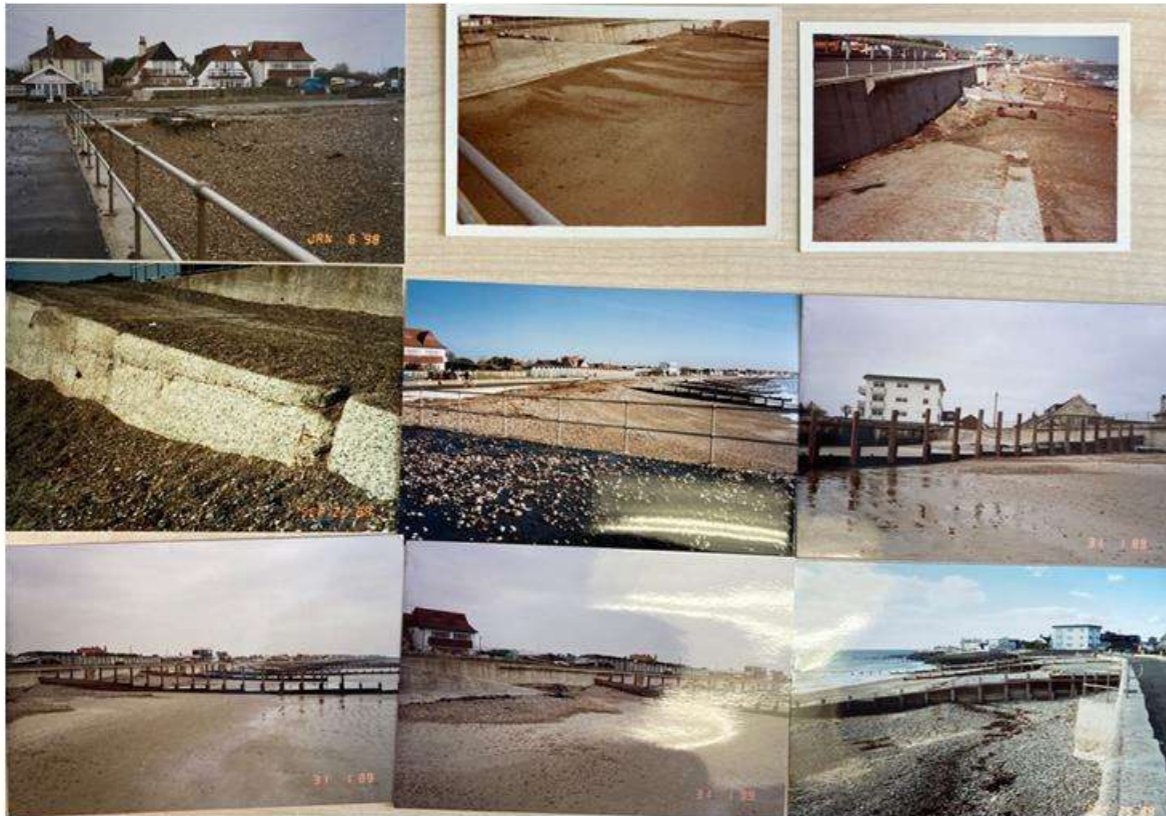
Figure 5 - Historic photographs Canning Road (Old Ramp)

Removal of the shingle from this location is not advised as the shingle beach provides protection to the seawall, property and infrastructure. The condition of the seawall is unknown and the historic images show superficial damage in 1989. They also show that by 1998 the face of wall had been completely covered by beach sediment and we can therefore determine that the condition has not been assessed in 25 - 34 years.

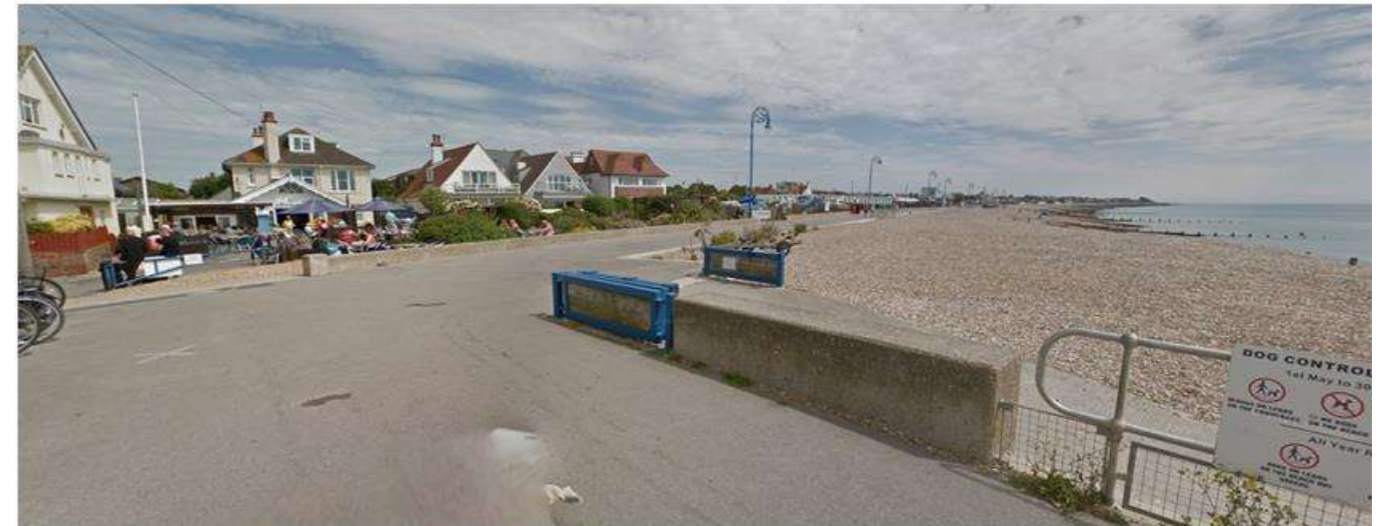
Figure 6 - Canning Road (Old Ramp), September 2019

The volume of beach sediment at site 2 is such that it would not be viable to consider resurrecting this ramp.

Removal of beach sediment from this location has the possibility of increasing coastal flooding and erosion risk.

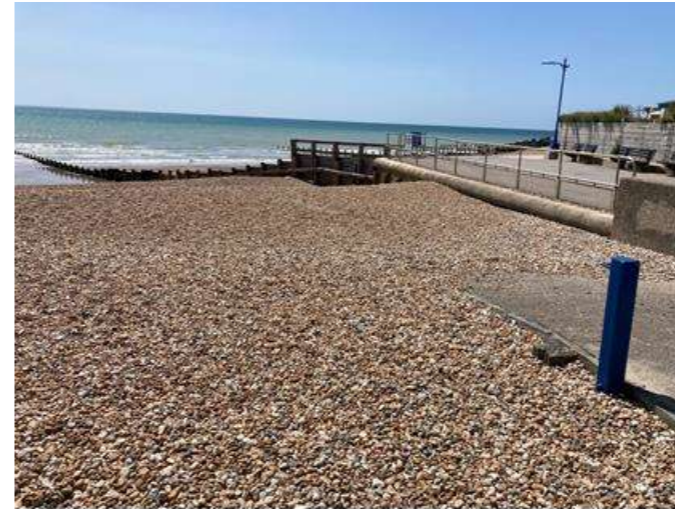
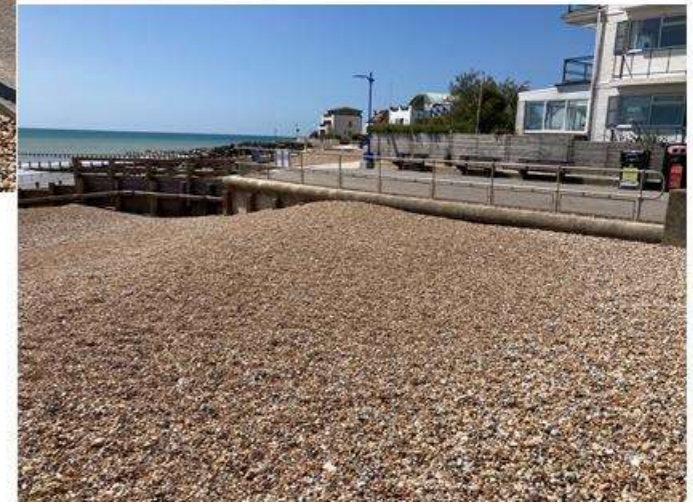
Figure 8 – Canning Road / Lobster Pot (Newer ramp), May 2023

Site 3 benefits from many of the same amenities as site 1, albeit further away – Toilets and parking are approximately 200m away.

The major drawback to this location is the frequency of shingle clearance required. As the ramp is located on the junction of a stepped bay it is frequently overtopped with beach sediment due to the longshore transport regime. Furthermore, due to being situated further landward with respect to the foreshore it is also subjected to sediment inundation during drift reversal events (south-easterly, easterly and north easterly waves). For these reasons it would not be economically viable to select this ramp as a preferred options.

However, it would be prudent to consider that this ramp may be able to be cleared 'when time permits' during major shingle clearance operations. For this reason, this ramp could be cleared on an ad-hoc basis.

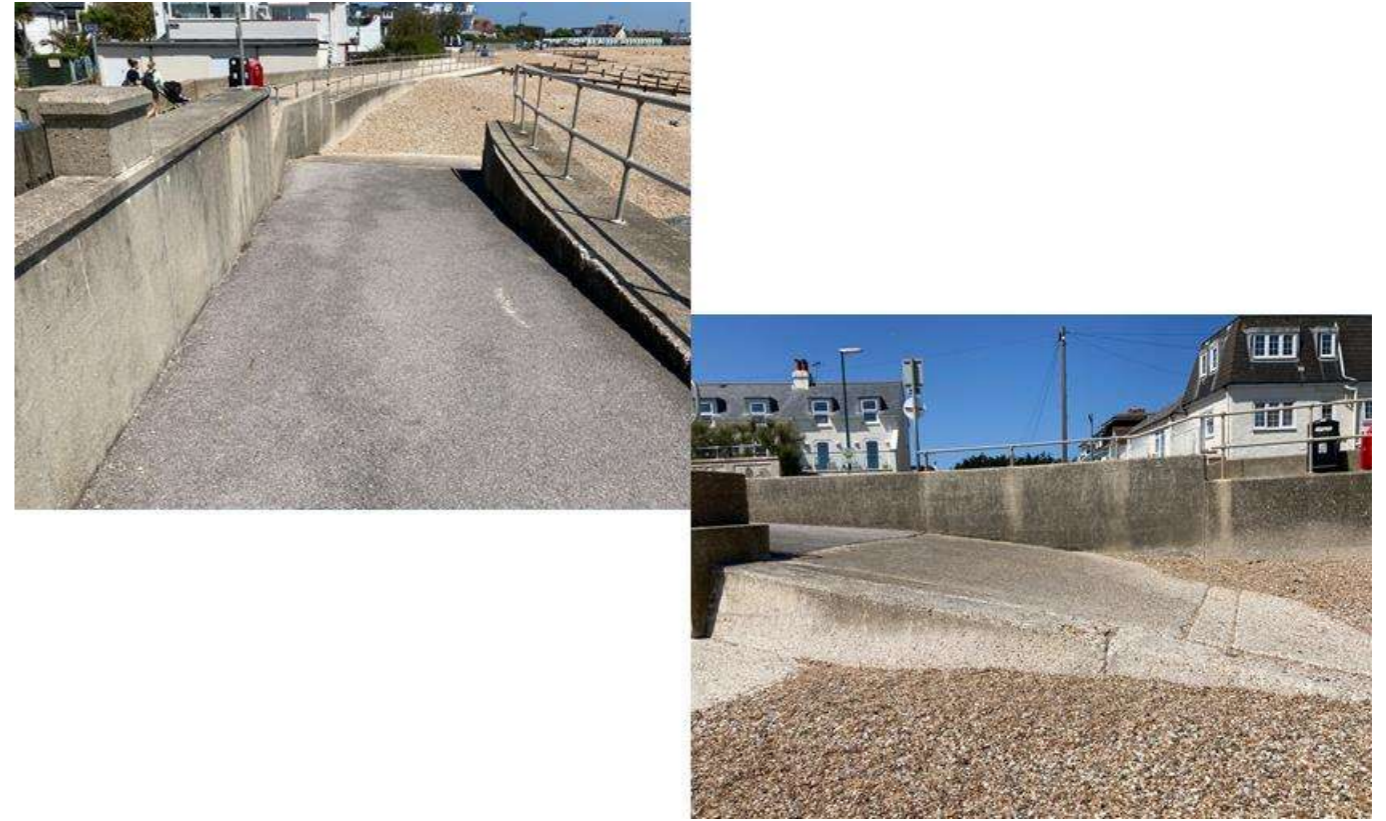
Figure 10 - Outram Road, May 2023

Site 4 does not meet the objectives of the project and is remote by comparison. Access to the ramp itself is more difficult than many of the other offerings and has therefore not been shortlisted.

Considerations ruling out shortlisting include; the inability to access the lower foreshore, the remoteness of the ramp, costs associated with regular clearance, the lack of facilities, the lack of general access and the risk of entrapment.

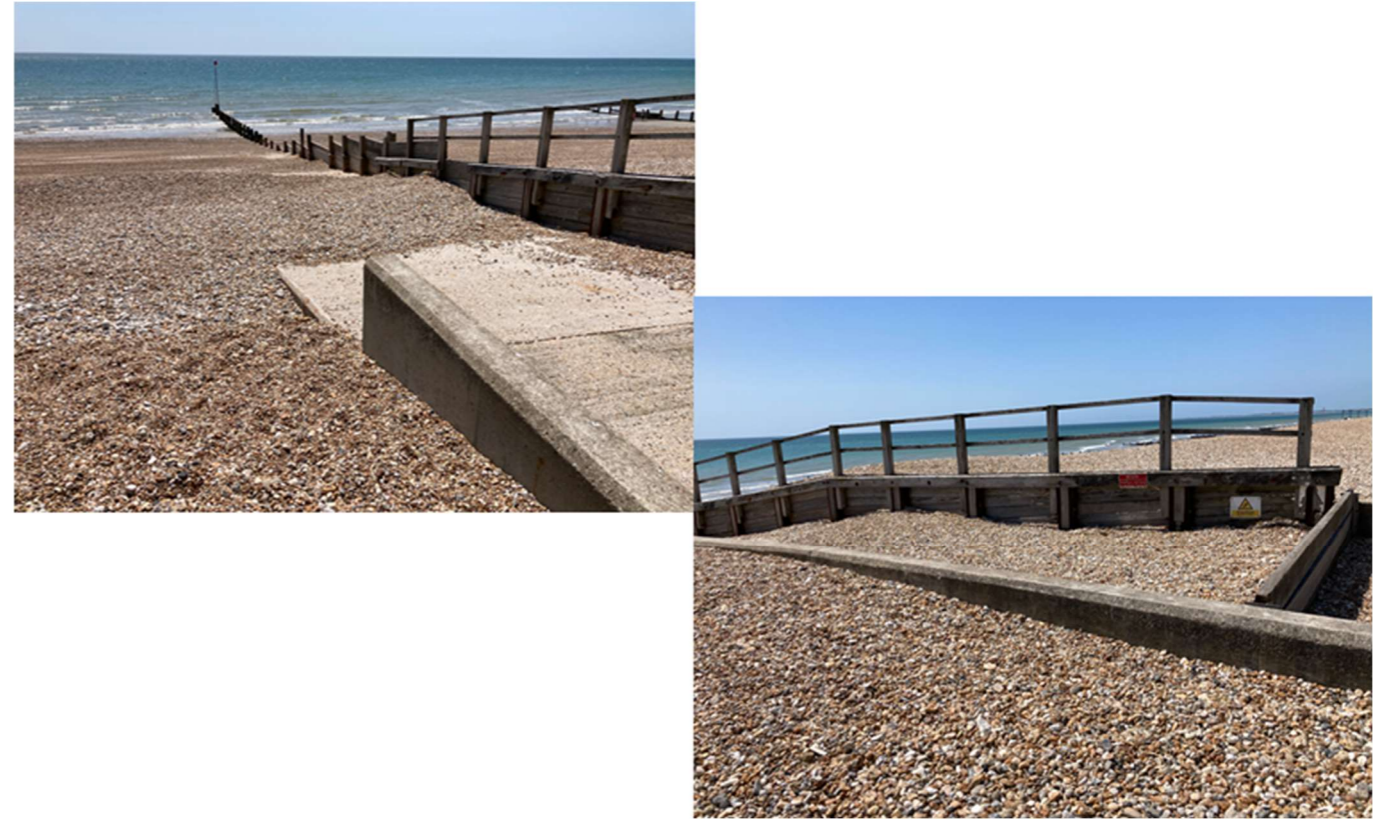
Figure 12 - Gloucester Road, May 2023

Site 5 is another preferred site and benefits from accessible parking, public toilets and cafes within a 125m radius. It is also located in fairly close proximity to the town centre giving access to a plethora of shops, café's and activities.

The main drawback of site 5 is that it has contractual challenges and historic use expectations that need to be overcome. expectations based on historic use. These will need to be overcome before Arun District Council are able to begin improving the offering. Additionally, access between the accessible parking and offering has a more challenging route consisting of either; narrow paths and ramps or, being situated an extended distance from the asset. This asset would benefit from upgrading the access chain, specifically, the access route between the parking and offering.

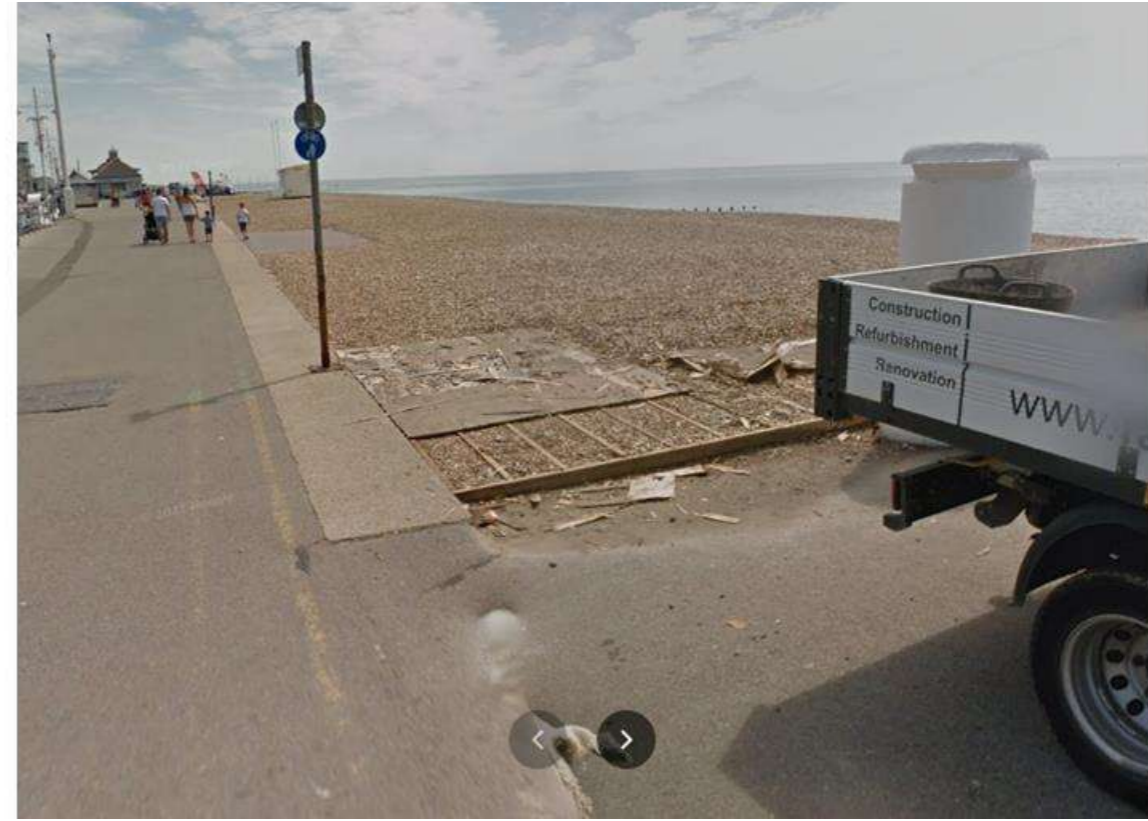
Figure 14 - Regis Centre, Sept 2019

Site Offering - Site 6, Regis Centre (existence not verified)	
Asset owned by Arun District Council	✓
Leases covering operation of asset	No
Frequency of shingle clearance required (Low, Medium, High)	High
Off-street parking (Within 100m)	✓
Off-street accessible parking (Within 100m)	✓
Public Toilets	✓
Public Accessible Toilets	✓
Lifeguarded Beach	✓
Nearby Inclusive Café's / Facilities	✓
Bus route (within 300m)	✓
Train station (within 1000m)	✓
Modifications possible to facilitate rest areas	✗
Clearance Likely to Negatively Impact Flood and Erosion Risk	Yes
Access to lower beach	✗
Maintenance costs (£ - ££££)	££££

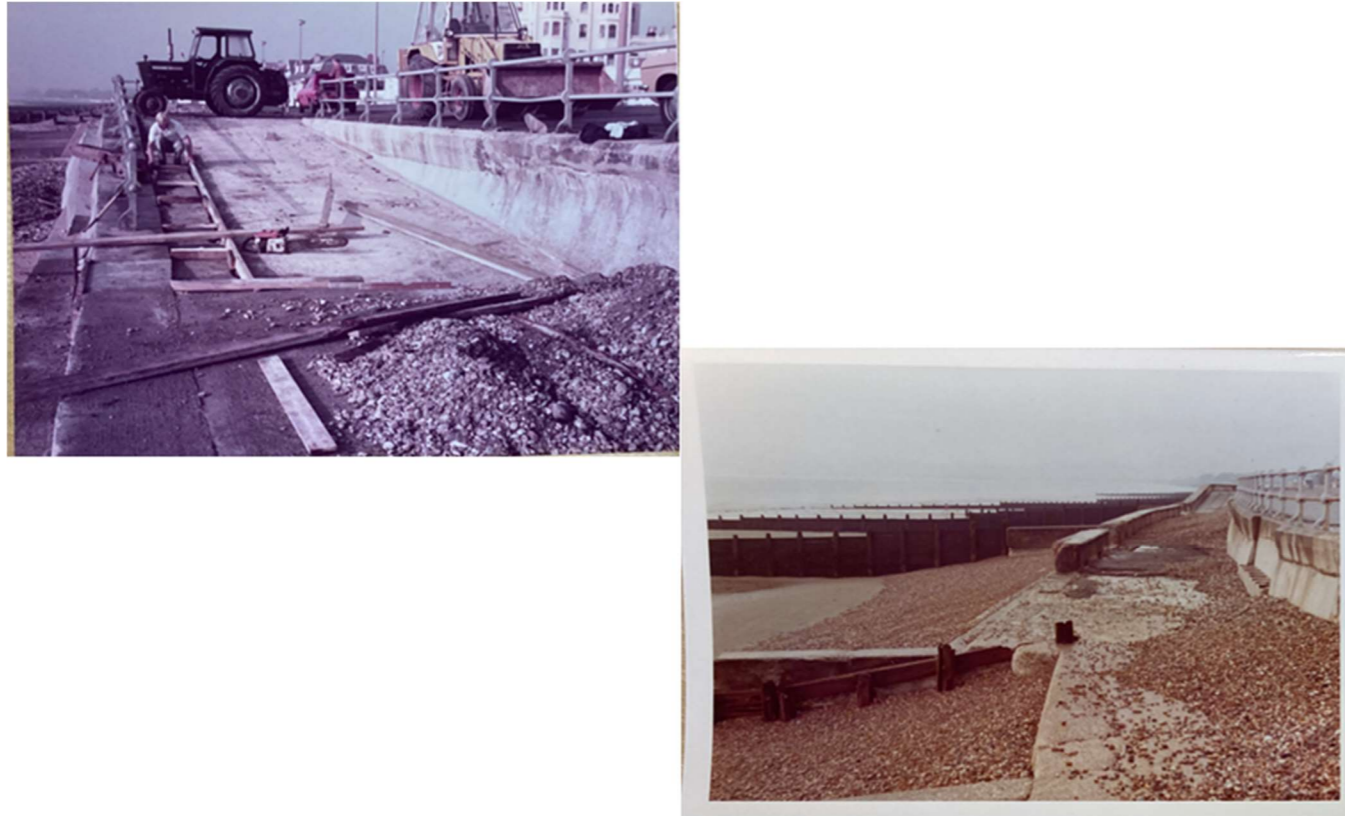
Figure 17- Historic Photographs of Marine Parade

The ramp terminates above the sand level and appears to have spending steps for a portion of the journey to the lower foreshore, see Figure 17. Additionally, the ramp is inundated with beach sediment and removal of the material will increase flood and erosion risk.

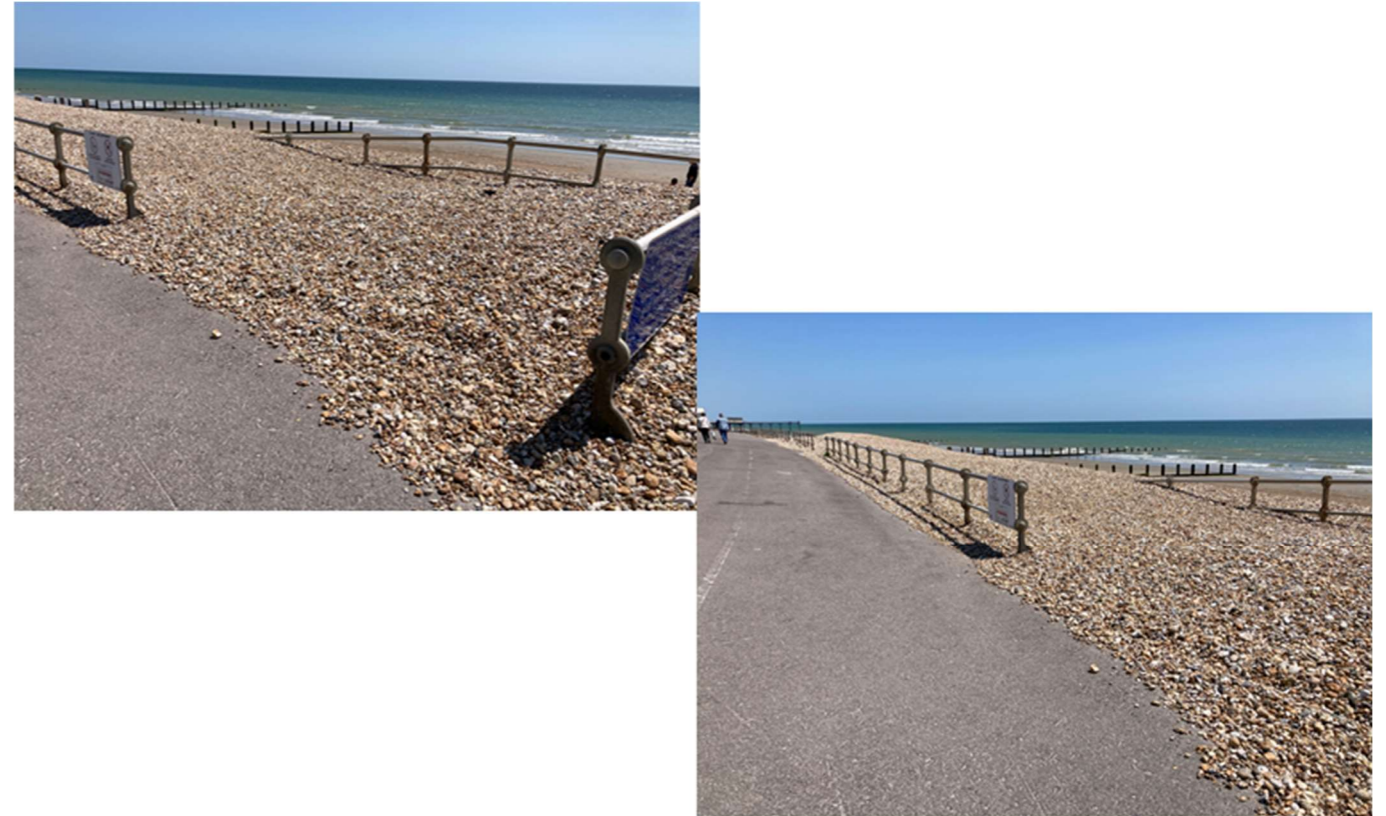
Figure 18 - Marine Parade, May 2023

Site 8 has not be shortlisted as it does not meet the objectives agreed by the working party.

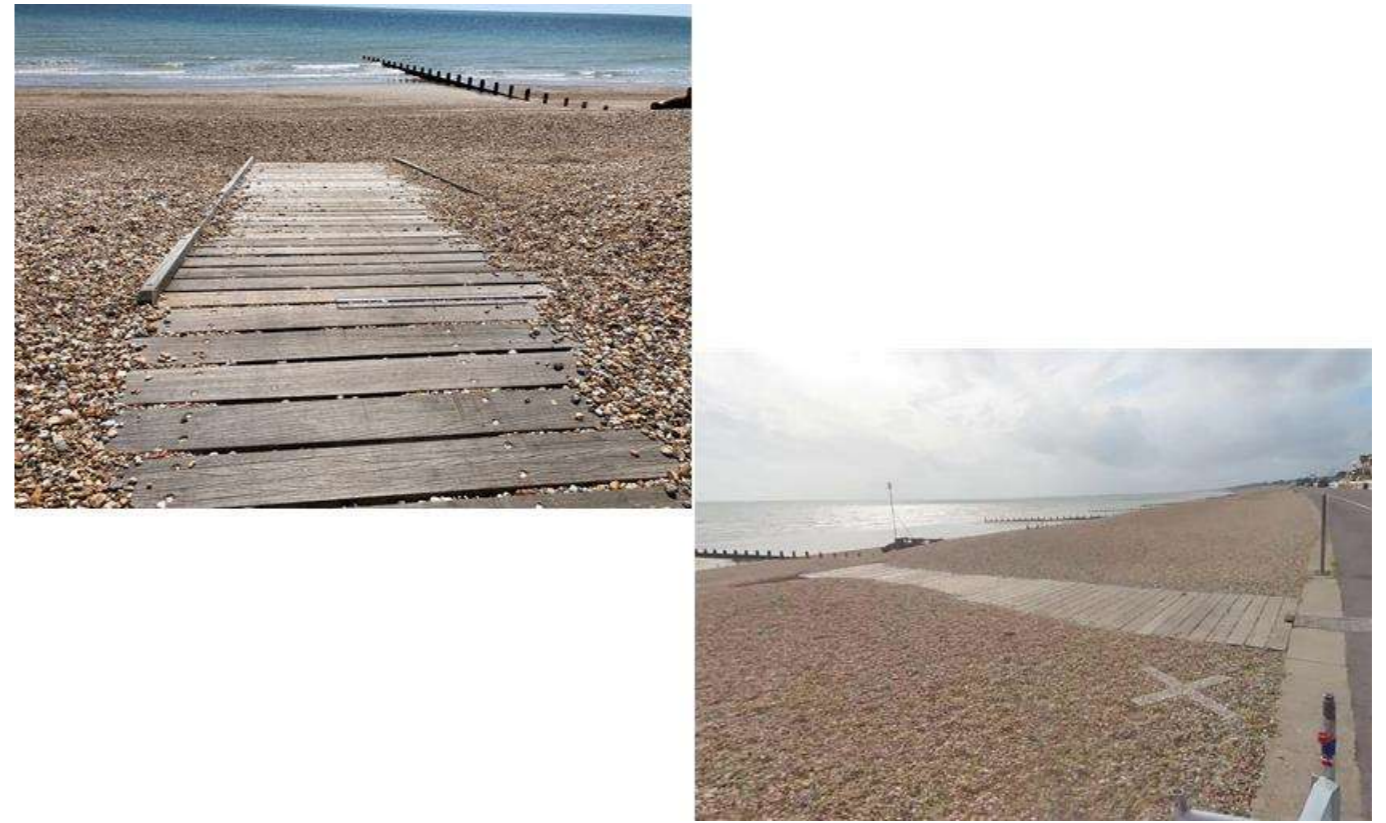
Figure 20 Victoria Road South, May 2023 and Sept 2019

Site 9 has not be shortlisted as it does not meet the objectives agreed by the working party, specifically it does not extend to the lower foreshore.

One major benefit of this ramp is its seaward position relative to the foreshore. However, clearance of this ramp as part of this project would not meet the objectives.

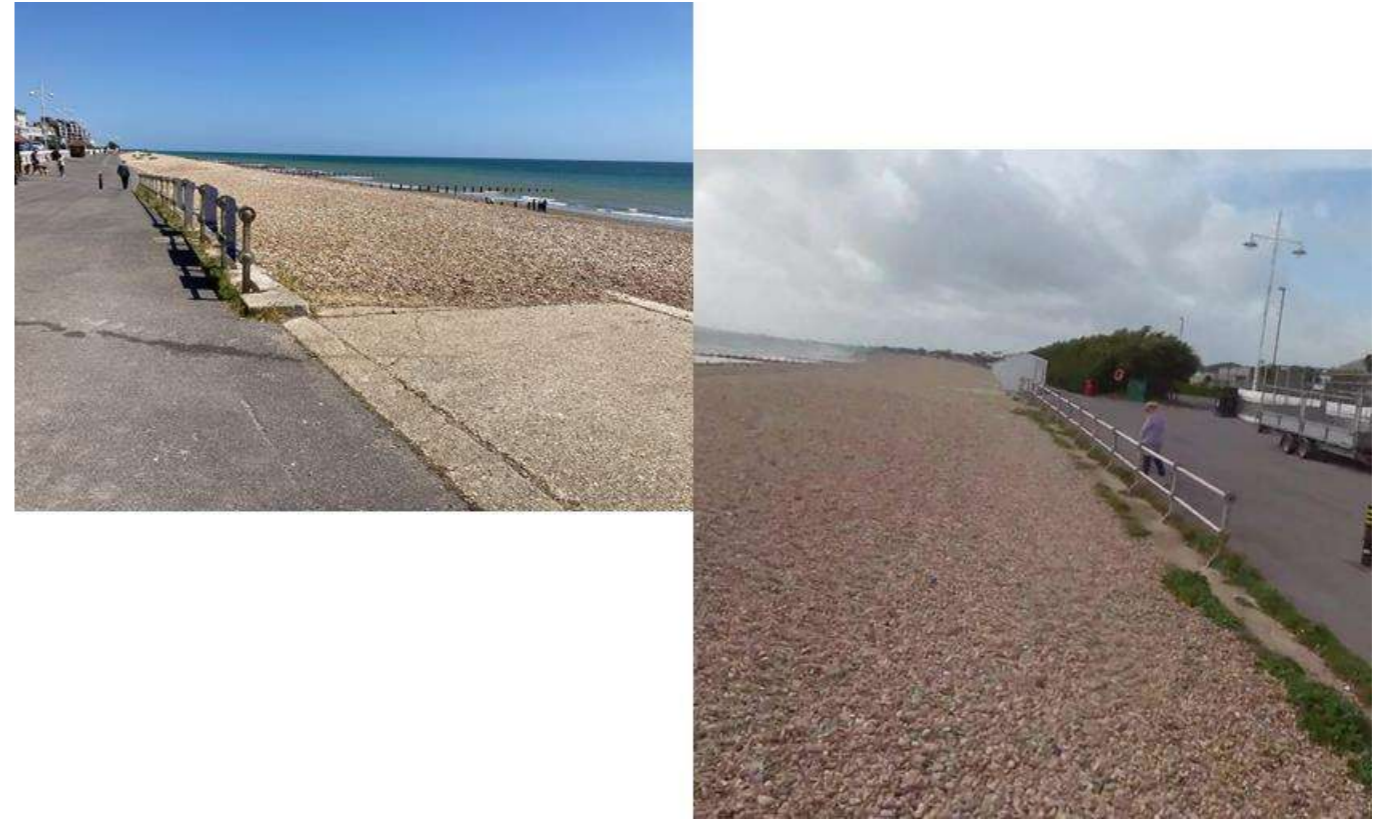
Figure 22 - Nyewood Lane, May 2023 and Sept 2019

Site 10 has not be shortlisted as it does not meet the objectives agreed by the working party.

Desk studies and site surveys were unable to verify the exact design of the ramp but it is believed to be similar in construction to that of the ramp at site 8. Furthermore, removal of sediment from this piece of foreshore would significantly increase flood and erosion risk.
