## Asbestos Re-inspection Report

The Arcade  
Bognor Regis  
West Sussex  
PO21 1LL

Reference: C-19506

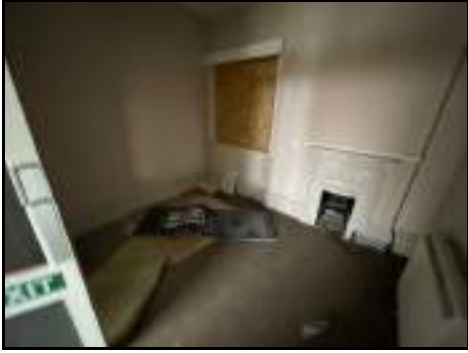
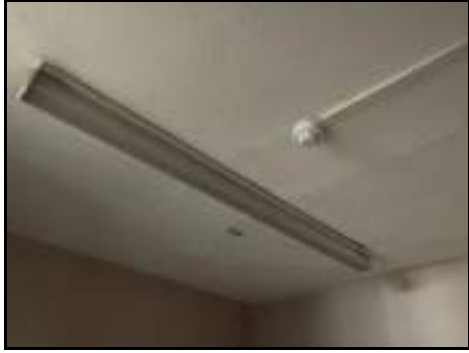
Building:	The Arcade	Floor	1st Floor
Location ID	051	Location	Room 12
Sample Number	X016	Extent	<25 m <sup>2</sup>
External Sample Ref			
Item / Position	Ceiling	Material	Textured Coating
Product Type	Asbestos reinforced composites etc.	Scores	1
Condition	Low Damage		1
Surface Treatment	Sealed		1
Asbestos Type	<b>Chrysotile</b>		1
Material Assessment	Very Low		4
Substrate	bonded to plaster	Accessibility	Medium
<b>Main Photo</b>		<b>Close Up Photo</b>

Recommendation	<p><b>Remove - NON-Licensed Material Removal by an asbestos contractor. This material is not licensed however may still be notifiable to the HSE prior to removal works taking place. All works must conform to the Control of Asbestos Regulations 2012.</b></p>		
Comments	bonded to plaster

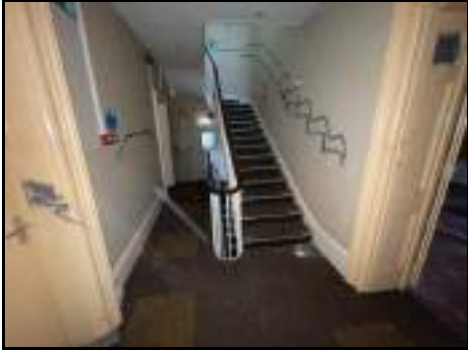
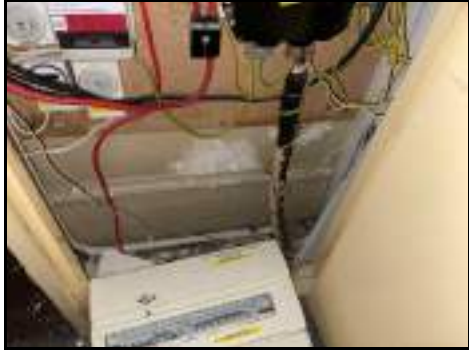
Building:	The Arcade	Floor	1st Floor
Location ID	052	Location	Landing Including Stairwell
Sample Number	SP	Extent	1 lin m
External Sample Ref			
Item / Position	Bitumen Linings	Material	Bituminous Product
Product Type	Asbestos reinforced composites etc.	Scores	1
Condition	Good Condition		0
Surface Treatment	Sealed		1
Asbestos Type	<b>Strongly Presumed Chrysotile</b>		1
Material Assessment	Very Low		3
Substrate	Bonded to metal	Accessibility	Low
<b>Main Photo</b>		<b>Close Up Photo</b>

Recommendation	<b>Inaccessible Items / Strongly Presumed Inaccessible item. Isolation, access and sampling will be required prior to any works which may disturb the presumed item.</b>		
Comments	Bonded to metal

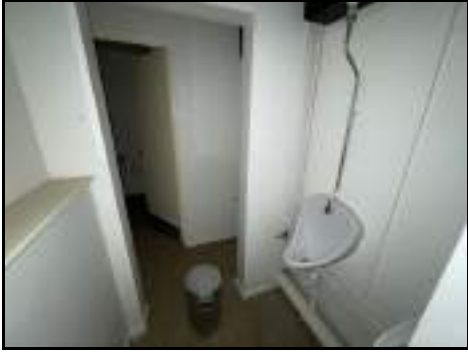
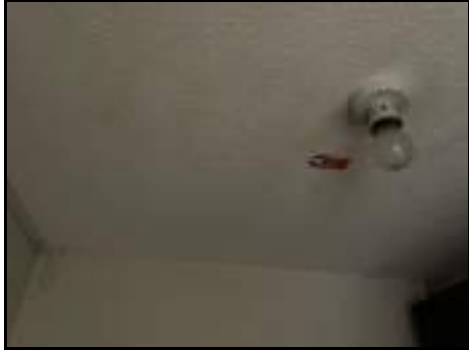
Building:	The Arcade	Floor	1st Floor
Location ID	053	Location	Male WC
Sample Number	X016	Extent	<10 m <sup>2</sup>
External Sample Ref			
Item / Position	Ceiling	Material	Textured Coating
Product Type	Asbestos reinforced composites etc.	Scores	1
Condition	Good Condition		0
Surface Treatment	Sealed		1
Asbestos Type	<b>Chrysotile</b>		1
Material Assessment	Very Low		3
Substrate	bonded to plaster	Accessibility	Medium
<b>Main Photo</b>		<b>Close Up Photo</b>

Recommendation	<p><b>Remove - NON-Licensed Material Removal by an asbestos contractor. This material is not licensed however may still be notifiable to the HSE prior to removal works taking place. All works must conform to the Control of Asbestos Regulations 2012.</b></p>		
Comments	bonded to plaster

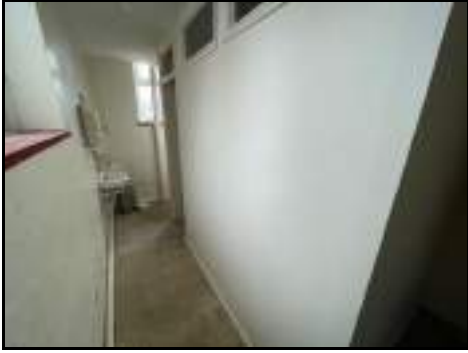
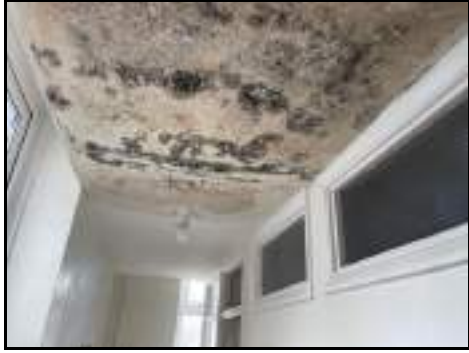
Building:	The Arcade	Floor	1st Floor
Location ID	054	Location	Female WC
Sample Number	X016	Extent	<10 m <sup>2</sup>
External Sample Ref			
Item / Position	Ceiling	Material	Textured Coating
Product Type	Asbestos reinforced composites etc.	Scores	1
Condition	Good Condition		0
Surface Treatment	Sealed		1
Asbestos Type	<b>Chrysotile</b>		1
Material Assessment	Very Low		3
Substrate	bonded to plaster	Accessibility	Medium
<b>Main Photo</b>		<b>Close Up Photo</b>

Recommendation	<p><b>Remove - NON-Licensed Material Removal by an asbestos contractor. This material is not licensed however may still be notifiable to the HSE prior to removal works taking place. All works must conform to the Control of Asbestos Regulations 2012.</b></p>		
Comments	bonded to plaster

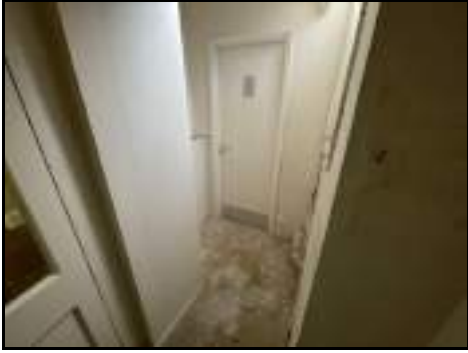
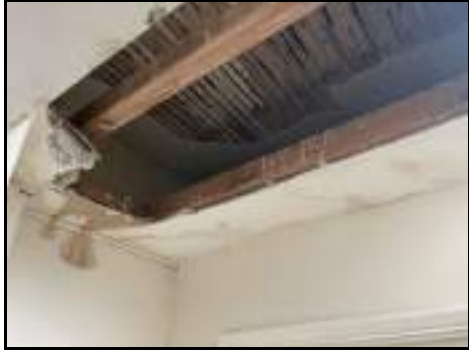
Building:	The Arcade	Floor	1st Floor
Location ID	055	Location	WC lobby
Sample Number	X016	Extent	<1 m <sup>2</sup>
External Sample Ref			
Item / Position	Ceiling and Debris	Material	Textured Coating
Product Type	Asbestos reinforced composites etc.	Scores	1
Condition	Medium Damage		2
Surface Treatment	Sealed		1
Asbestos Type	<b>Chrysotile</b>		1
Material Assessment	Low		5
Substrate	bonded to plaster	Accessibility	Medium
<b>Main Photo</b>		<b>Close Up Photo</b>

Recommendation	<p><b>Remove - NON-Licensed Material Removal by an asbestos contractor. This material is not licensed however may still be notifiable to the HSE prior to removal works taking place. All works must conform to the Control of Asbestos Regulations 2012.</b></p>		
Comments	bonded to plaster

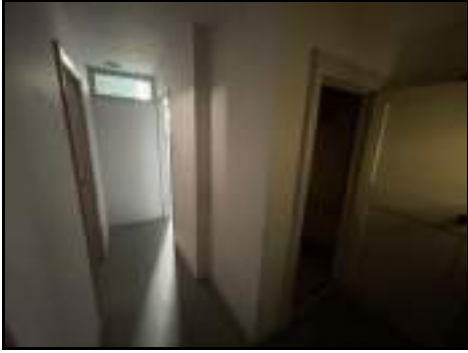
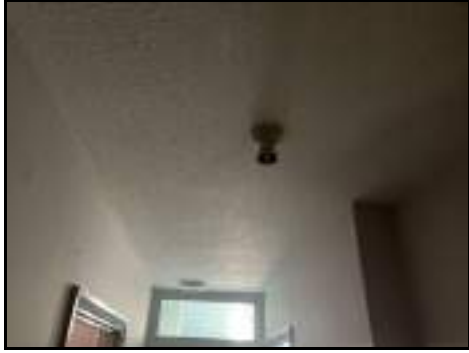
Building:	The Arcade	Floor	1st Floor
Location ID	064	Location	WC Area 2
Sample Number	X016	Extent	<8 m <sup>2</sup>
External Sample Ref			
Item / Position	Ceiling	Material	Textured Coating
Product Type	Asbestos reinforced composites etc.	Scores	1
Condition	Good Condition		0
Surface Treatment	Sealed		1
Asbestos Type	<b>Chrysotile</b>		1
Material Assessment	Very Low		3
Substrate	bonded to plaster	Accessibility	Medium
<b>Main Photo</b>		<b>Close Up Photo</b>

Recommendation	<p><b>Remove - NON-Licensed Material Removal by an asbestos contractor. This material is not licensed however may still be notifiable to the HSE prior to removal works taking place. All works must conform to the Control of Asbestos Regulations 2012.</b></p>		
Comments	bonded to plaster

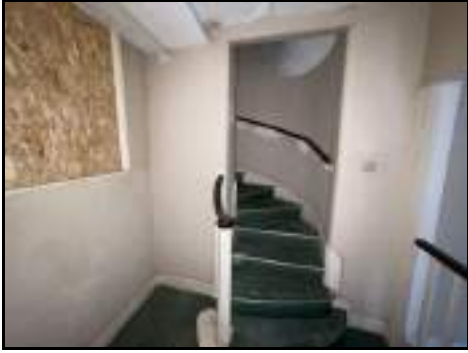
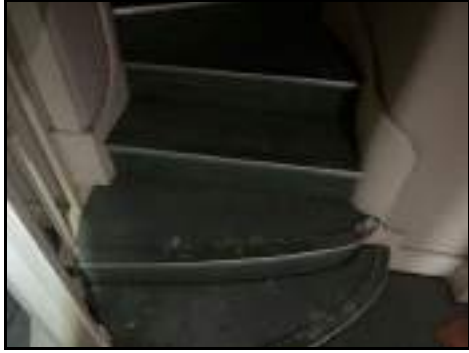
Building:	The Arcade	Floor	Ground Floor
Location ID	076	Location	Lobby
Sample Number	PS027	Extent	<11 lin m
External Sample Ref			
Item / Position	Stairnosings	Material	PVC / Reinforced Plastics
Product Type	Asbestos reinforced composites etc.	Scores	1
Condition	Good Condition		0
Surface Treatment	Self Sealed		0
Asbestos Type	<b>Chrysotile</b>		1
Material Assessment	Very Low		2
Substrate	bonded to timber	Accessibility	Medium
<b>Main Photo</b>		<b>Close Up Photo</b>

Recommendation	<p><b>Remove - NON-Licensed Material Removal by an asbestos contractor. This material is not licensed however may still be notifiable to the HSE prior to removal works taking place. All works must conform to the Control of Asbestos Regulations 2012.</b></p>		
Comments	<p>modern electrics                  bonded to timber</p>

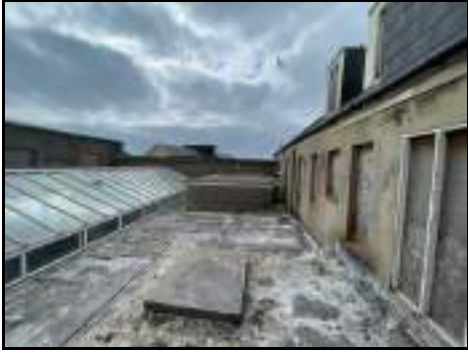
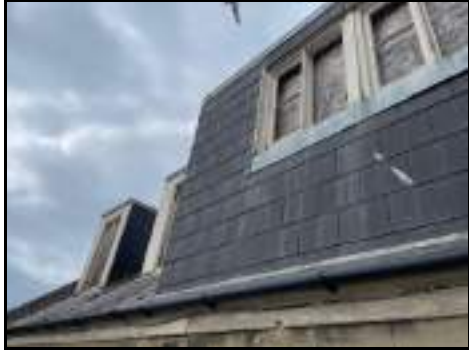
Building:	The Arcade	Floor	External
Location ID	074	Location	External Elements
Sample Number	PS024	Extent	<120 m <sup>2</sup>
External Sample Ref			
Item / Position	Roof Tiles	Material	Cement Product
Product Type	Asbestos reinforced composites etc.	Scores	1
Condition	Good Condition		0
Surface Treatment	Sealed		1
Asbestos Type	<b>Chrysotile</b>		1
Material Assessment	Very Low		3
Substrate	Nailed to timber	Accessibility	Low
<b>Main Photo</b>		<b>Close Up Photo</b>

Recommendation	<p><b>Remove - NON-Licensed Material Removal by an asbestos contractor. This material is not licensed however may still be notifiable to the HSE prior to removal works taking place. All works must conform to the Control of Asbestos Regulations 2012.</b></p>		
Comments	Nailed to timber

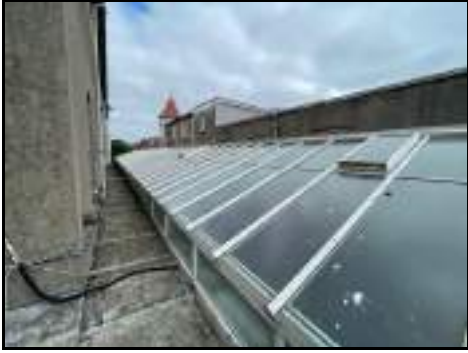
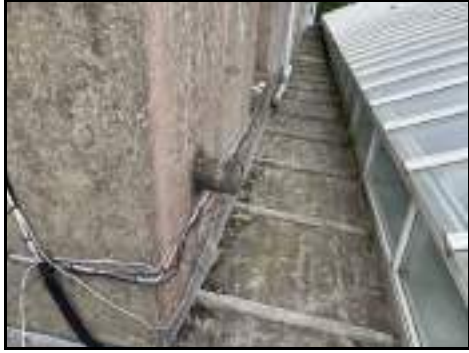
Building:	The Arcade	Floor	External
Location ID	074	Location	External Elements
Sample Number	PS025	Extent	<1 lin m
External Sample Ref			
Item / Position	Flue	Material	Cement Product
Product Type	Asbestos reinforced composites etc.	Scores	1
Condition	Good Condition		0
Surface Treatment	Sealed		1
Asbestos Type	<b>Chrysotile</b>		1
Material Assessment	Very Low		3
Substrate	Nailed to timber	Accessibility	Low
<b>Main Photo</b>		<b>Close Up Photo</b>

Recommendation	<p><b>Remove - NON-Licensed Material Removal by an asbestos contractor. This material is not licensed however may still be notifiable to the HSE prior to removal works taking place. All works must conform to the Control of Asbestos Regulations 2012.</b></p>		
Comments	Nailed to timber
