ROYAL HALL, BOGNOR REGIS
FEASIBILITY REPORT
ARUN DISTRICT COUNCIL
1st March 2024

Royal Hall Feasibility Report

5024385 – BREWERS FAYRE, BOGNOR REGIS BUILDING CONDITION REPORT

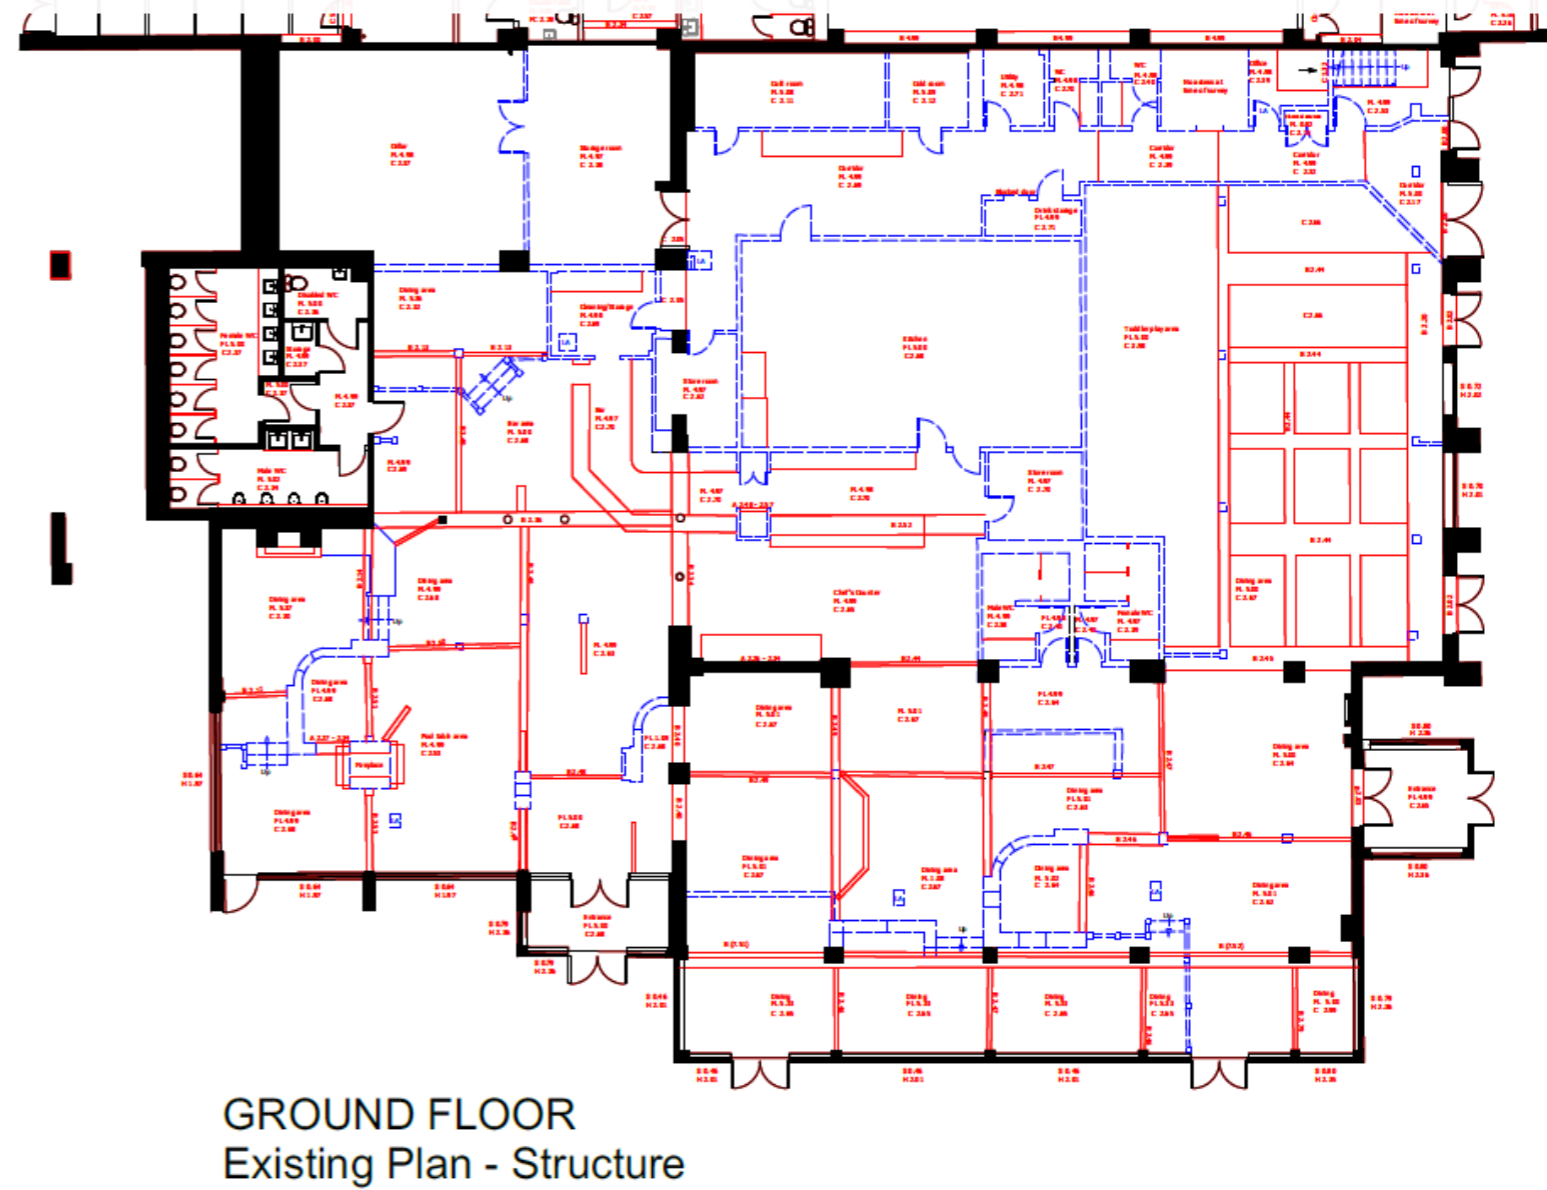
Figure 3: Structural elements plan

Since its establishment in 1996, Brewers Fayre has undergone several internal fit-out modifications to the building, primarily considered non-structural in nature. The principal structural change involves the addition of a mezzanine level situated on the eastern elevation, outlined in Figure 2 (brown area). While the foundations of the new mezzanine are presently unknown, there is a belief that the columns may be directly supported by the ground floor slab.

Moreover, a comparison between the current layout and record drawings suggests the potential removal of two load-bearing walls, replaced by steel columns (Figure 2, red area). The foundations of these columns are currently undocumented. The remaining structural elements, (Figure 2, yellow area) are in keeping with record drawings.

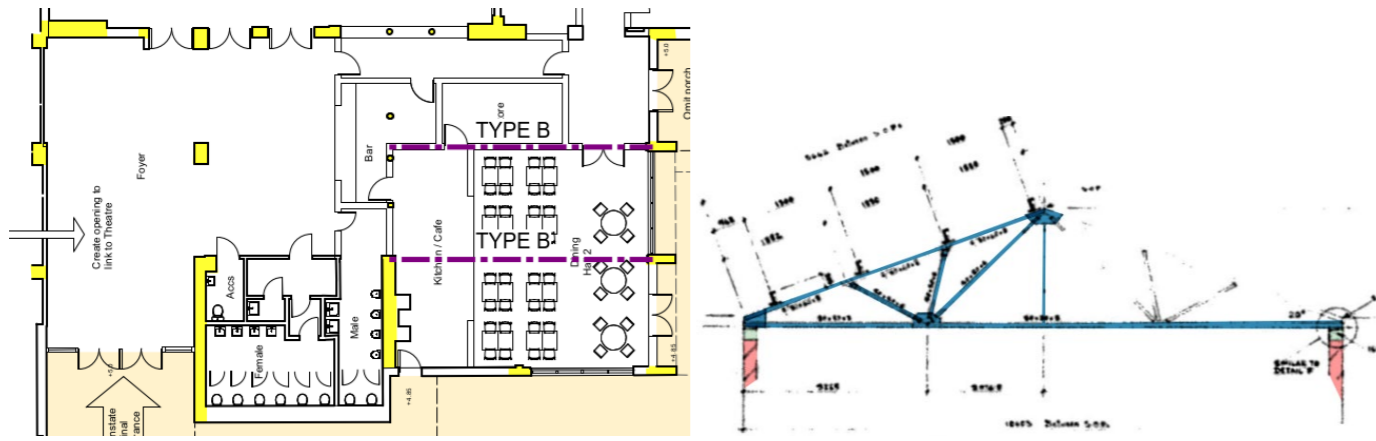
Figure 12: Small Hall Area (Option 1) or Café Space (Option 2) and Foyer Area.

The steel truss spans onto concrete padstones which in turn are being supported by masonry walls/piers. It is believed that a masonry wall has been removed from this space and was replaced with steel columns. Foundations and conditions of these supports will have to be assessed once the fixtures and finishes have been removed.

Depending on the intended use of this space, a ceiling can be incorporated either in line with the bottom of the truss or at the underside of roof level, allowing the steel frame to be prominently expressed. The new foyer area is located where the original entrance used to be. Reinstatement of this area does not pose any structural concerns in this space.

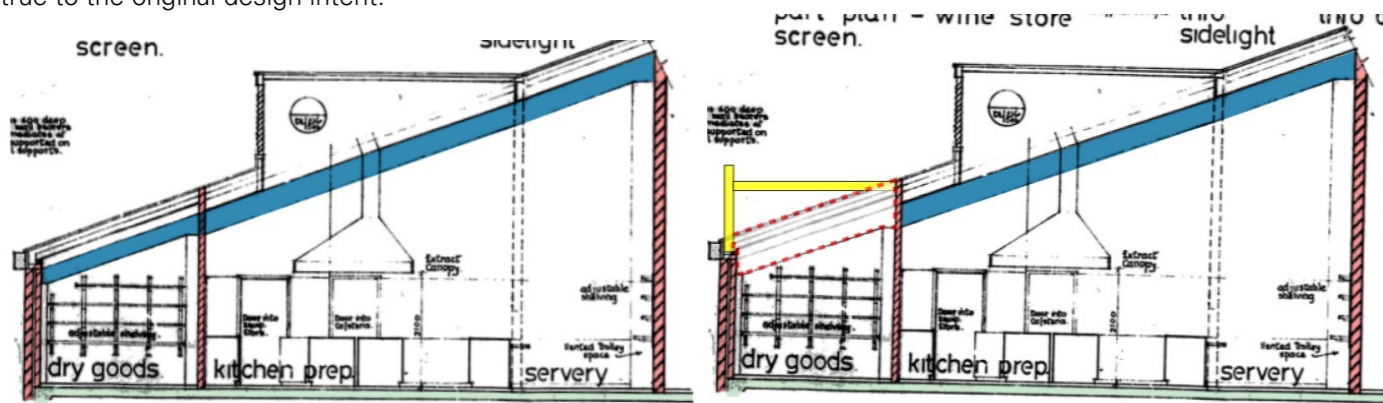
Figure 13: Original Design (left) and Existing Space Amenities and Office Space (right).

In both options this space is being converted to meeting rooms and other amenities. The original structure consists of a mono-pitch roof spanning from the multipurpose space to the external façade, Figure . However, during the fitout in 1996 it appears that a flat roof section and parapet was added to the façade. In general, the structure internally remains true to the original design intent.

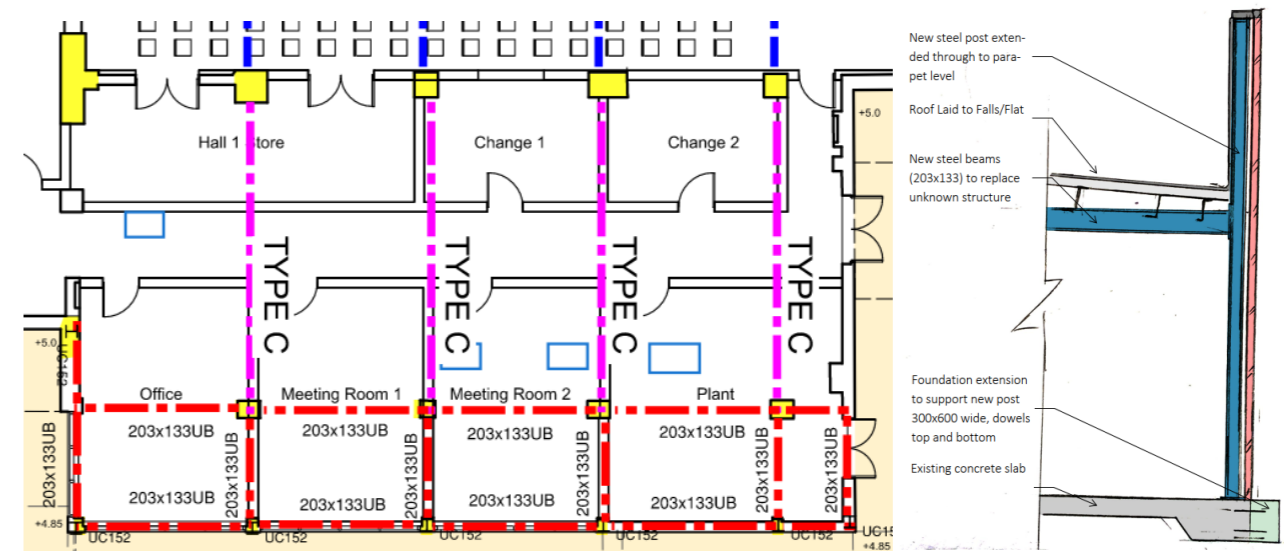
Figure 14: Proposed Roof Structural Alterations (left) and cross section (right)

Structural alterations to the facades are typically concentrated on the lean-to area which is part of the amenities and meeting rooms space. Here, the intent is to increase the parapet in line with the adjacent roof over the café area around the perimeter of this space affecting the east, west and southern elevations. In addition, a flat roof is being proposed over this area.

The combination of the two proposals requires additional steelwork both on the roof but also externally in order to allow for the parapet to be raised at that level. The following alterations are being proposed:

- Removal of the existing flat roof back to the first structural support line.
- Extension of existing foundations, typically with 300x600mm wide pad, doweled in the existing slab.
- Introduction of steel columns from foundation to parapet level.
- Installation of internal steel to support the new roof.
- Installation of a PFC at the top of the parapet to provide support.

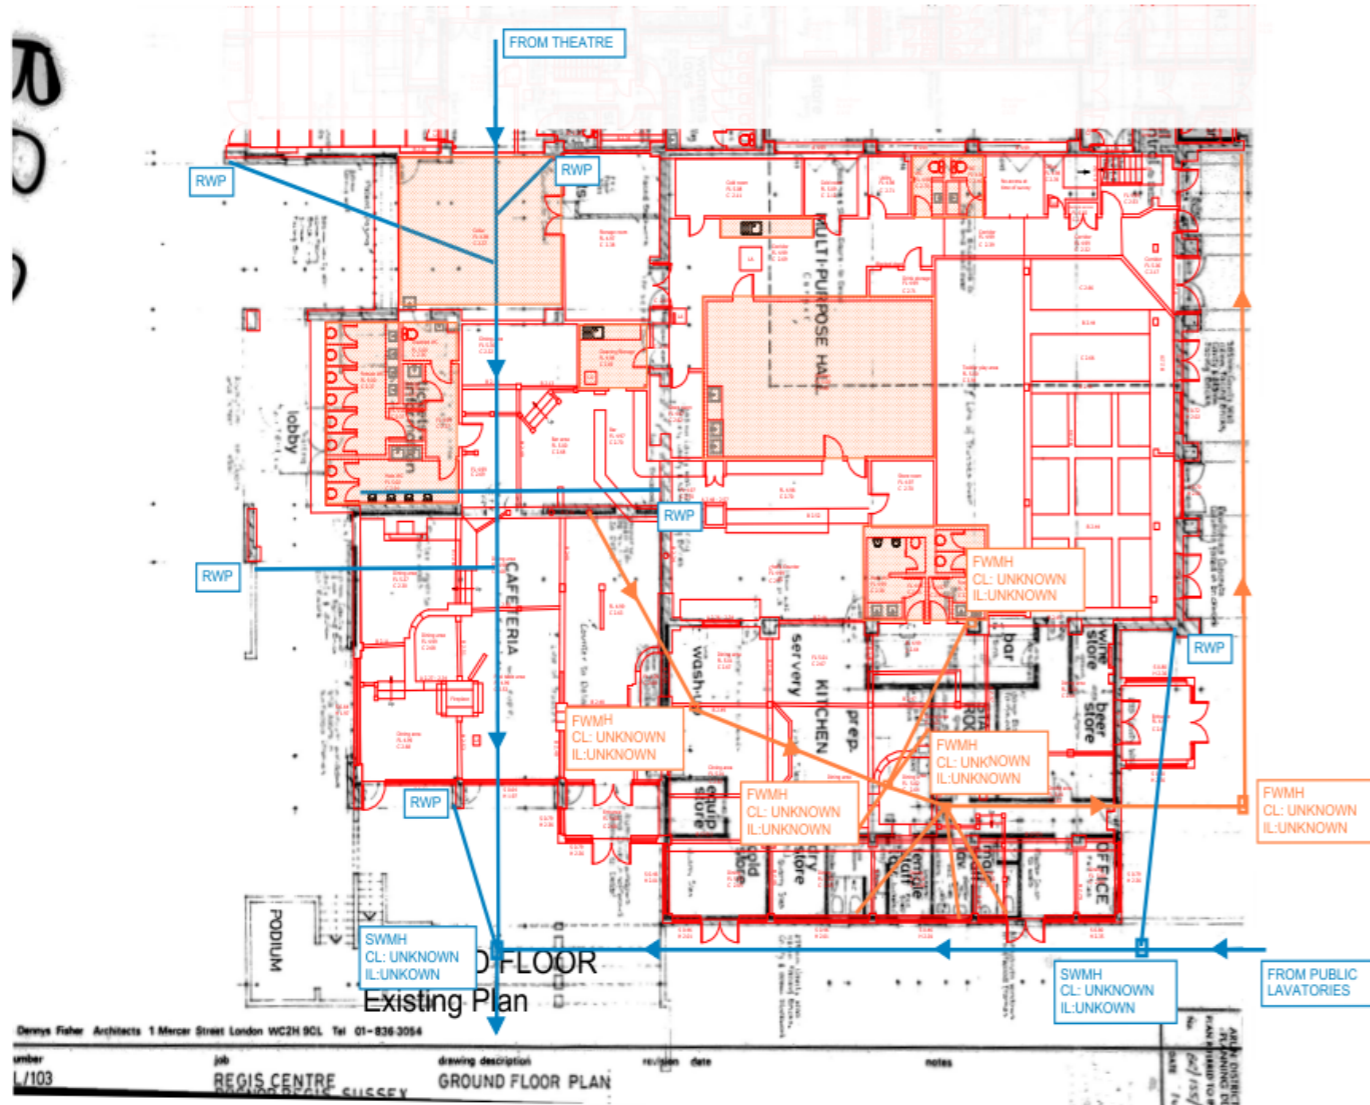
Figure 19: Brewers Fayre Overlay on Historical Plan showing Historic Drainage Layout

It is apparent from this overlay that new below ground drainage is likely to have been installed during the refurbishment to pick up drainage in these locations (shown hatched), however it is not known where these drain to.

It is therefore recommended that before the scheme is developed further, a detailed measured survey to locate the internal manholes is undertaken. It would also be of benefit to trace and locate the positions of any internal manholes installed as part of the Brewers Fayer refurbishment to fully understand any coordination, re-use and or capping off required.

We would also recommend that all of the internal and external below ground drainage networks are CCTV surveyed in order to understand their condition and whether any remediation / replacement is required.

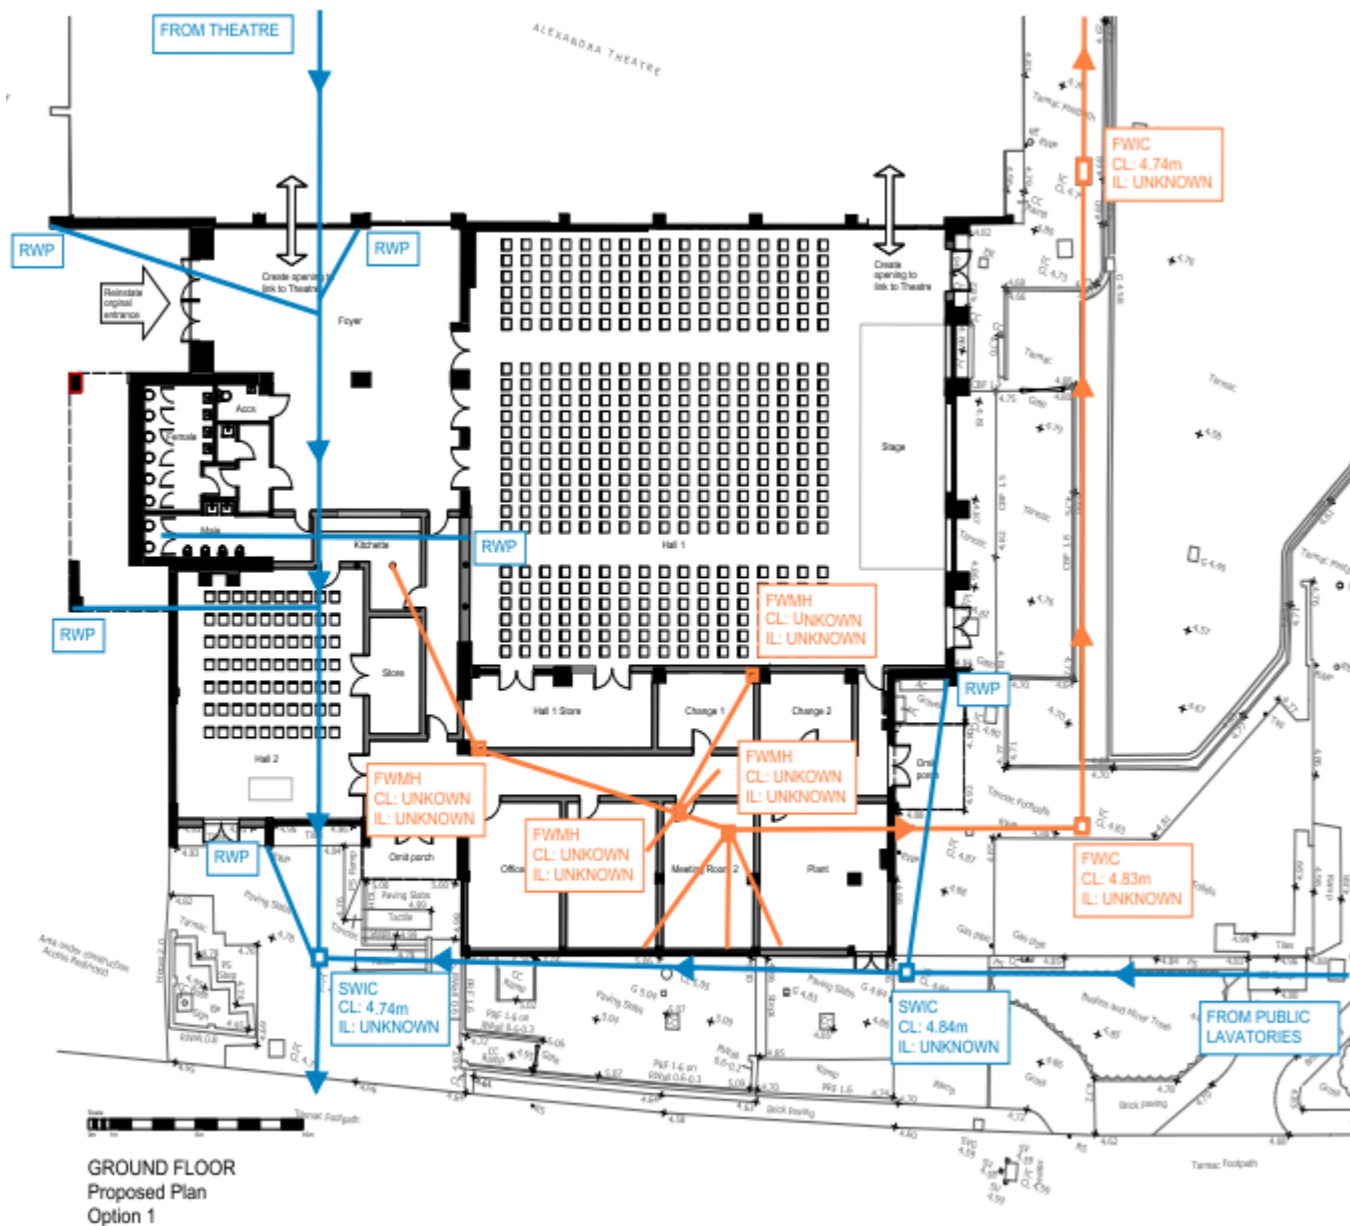
Figure 21: Proposed Option 1 Layout showing Historic Drainage Layout

One thing to be mindful of are the location of the existing internal manholes. As future access to these will be required, therefore the positioning of any new internal partitions will need to be accurately coordinated.

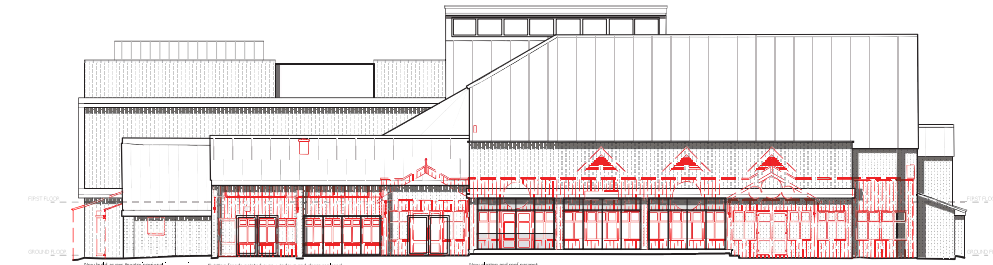
SOUTH ELEVATION

New built up roof panels proposed
Existing facade painted over, windows and doors replaced
Existing facade to be replaced with new facade proposed
Existing gutters and downpipes removed, existing windows replaced and fitted with new glazing
New glazing and roof panels

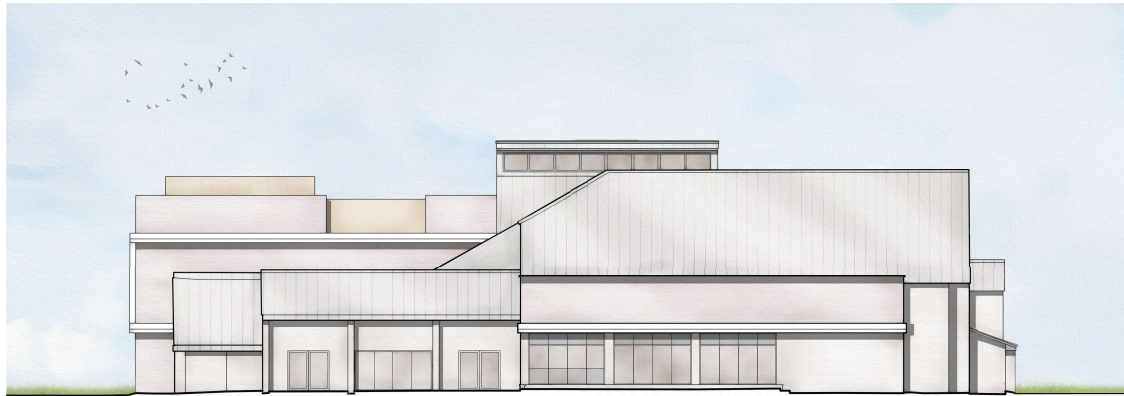
SOUTH ELEVATION

New built up roof panels proposed
Existing facade painted over, windows and doors replaced
New glazing and roof panels

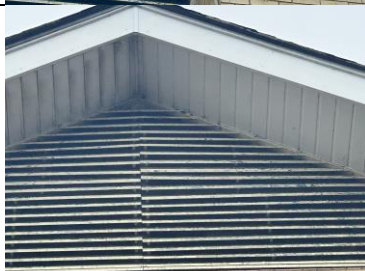
Louvre	<p>High level Louvre is located to provide ventilation into the plant room located within the roof.</p> <p>Louvre grille appears to be formed of aluminium and has heavy peeling and flaking of paintwork is noted.</p>	2	Allow for cleaning and redecoration of louvre grille.	2

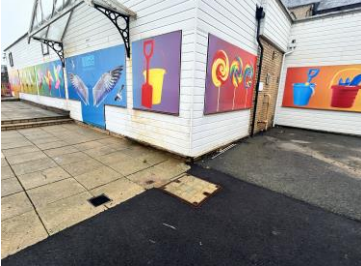
Cladding	Single storey section to South elevation has been over clad using uPVC shiplap style cladding. Across the elevation the cladding appears to be in a fair condition although it is noted that fixings to the items / services mounted across the elevation have rusted causing staining to the cladding.	2	Recommend removal of rusted fixings and replacement using suitable marine grade stainless steel fixings. Clean down staining to cladding.	2

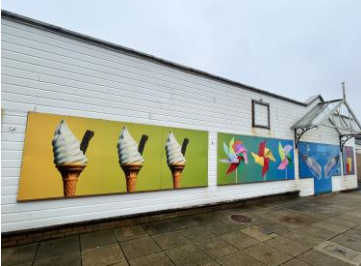
Windows	Note: Windows have been over boarded.		See recommendations made to windows within Section 2.3.

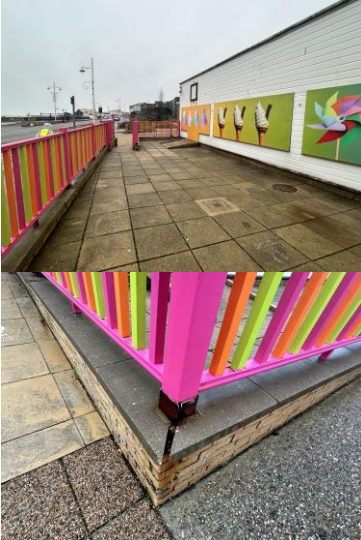
AREA	DESCRIPTION / ISSUE	CONDITION	RECOMMENDATION	PRIORITY	PHOTO REF
Hardstanding	<p>Raised paved hardstanding area to the front elevation of the property. Overall paved area appears to be in fair condition although it is noted that some paving slabs are broken.</p> <p>A low level wall separates the hardstanding from the adjacent pavement. It was observed that in some areas the capping stones appear to have been poorly cut to size with gaps evident to the corner sections.</p>	2	<p>Recommend replacement of broken or loose paving slabs.</p> <p>Recommend replacement of poorly installed corner capping stone.</p>	2

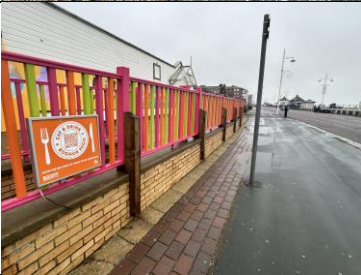
Fencing	<p>Timber fencing to the front side of the patio area separates the raised terrace from the pedestrian pavement. Timber fencing appears to be in fair condition.</p>	3	<p>Fencing should be maintained as part of regular scheduled maintenance plan.</p>	3

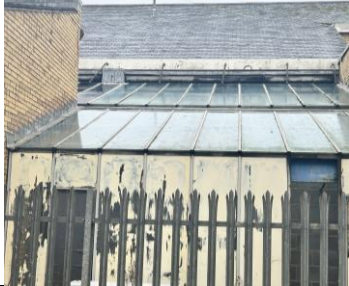
Windows	Aluminium framed Georgian wired glazed mono pitched infill section forming the 'beer cellar'. A number of the glazing panels have been smashed or damaged and overall appear to be in poor condition.	1	Replace smashed or damaged glazing.	1

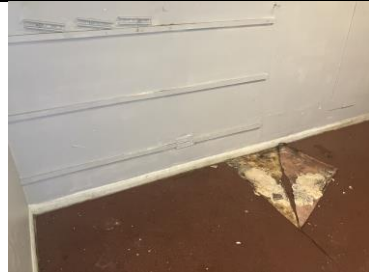
AREA	ISSUE	CONDITION	RECOMMENDATION	PRIORITY	PHOTO REF
Ceiling	Ceiling appears to be in fair condition. No comments made with regards to fire stopping.	2	Recommend redecoration of ceiling.	3	
Floor	Non slip textured vinyl sheet floor, in worn condition	2	Recommend replacement of vinyl flooring.	2	
Windows	No windows to room.				
Cupboard					
Door	Single timber door, no FD markings present. Door in worn condition.	2	Replace door.	2	
Walls	Walls appear to be in fair condition, localised damage to sections and previous fixings to walls.	2	Make good walls and redecorate.	2

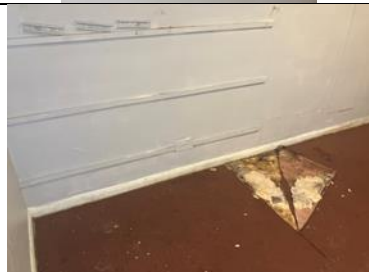
Floors	Non slip textured vinyl sheet floor, in worn condition and loose in sections.	2	Recommend replacement of vinyl flooring.	2

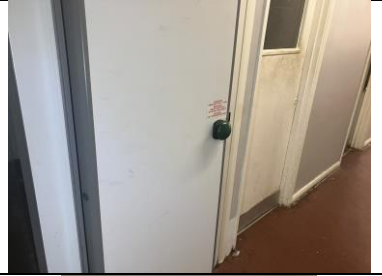
AREA	ISSUE	CONDITION	RECOMMENDATION	PRIORITY	PHOTO REF
Windows	No windows to room.				
Walk in Cold Room / Chiller					
Doors	Cold room hinged door, formed from insulated panel with laminate finish internally and white laminate finished aluminium externally. Door appears in good condition.	3	Recommend deep cleaning of door.	3

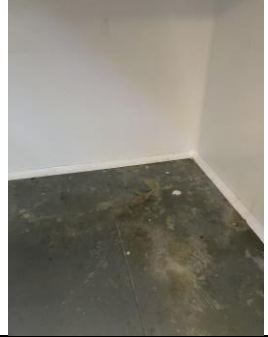
Walls	High density foam panels with white laminate finish internally, appear to be in fair condition.	2	Recommend deep cleaning of panels.	3

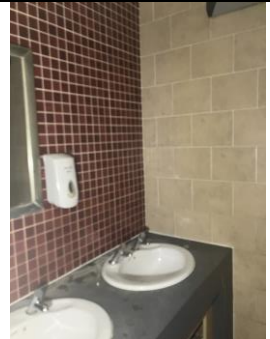
Windows	No windows to area.				
Bar Lobby - WC Male					
Door	Timber door with VP. Appears in poor condition.	3	Recommend replacement of door.	2	
Walls	<p>Damage to IPS panel to underside of sink, and IPS panels removed from rear of WCs.</p> <p>Full height tiling to walls within room, grouting heavily discoloured to low level areas.</p>	2	<p>Recommend repair and replacement of IPS units.</p> <p>Recommend regrouting of tiles.</p>	2

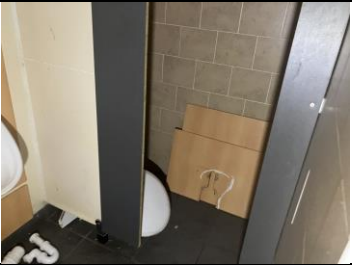
Windows	No windows to area.				
Sanitary Ware	WC has been uncoupled and pipework to the rear of the WC appears to have been damaged.	3	Recommend replacement of sanitaryware.	2

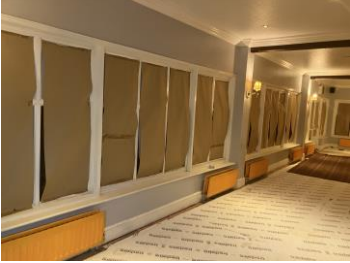
Windows	Double glazed uPVC windows, with top hung opening casements to high level. Windows have been boarded over externally. Noted that some windows appear to have been covered internally indicating they may be damaged / glazing broken.	2	Recommend servicing or wholesale replacement of windows.	2

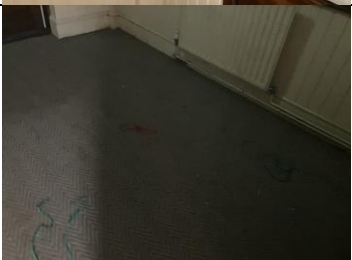
Floor	Carpet within porch areas appears to be worn.	2	Recommend replacement of flooring.	2

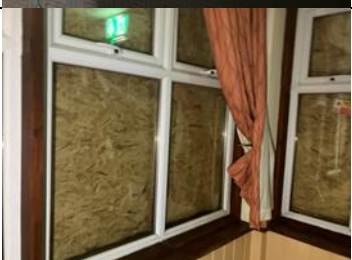
Windows	Double glazed uPVC windows, with top hung opening casements to high level. Windows have been boarded over externally. Noted that some windows appear to have been covered internally indicating they may be damaged / glazing broken.	2	Recommend servicing or wholesale replacement of windows.	2

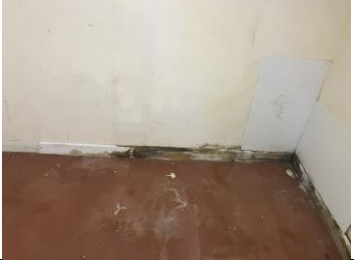
AREA	ISSUE	CONDITION	RECOMMENDATION	PRIORITY	PHOTO REF
Walls	Low level damage visible to walls and skirting, areas appear to be damp and skirting appears to be rotten. Sections of plaster to wall becoming debonded.	1	Further investigation recommended to ascertain the source of the water ingress. Allow to remove debonded sections of plaster and make good prior to redecoration of room.	1

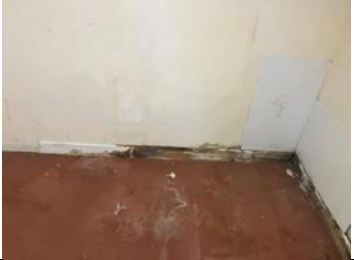
Ceiling	Ceiling is in fair condition, with some flaking of paint present.	2	Recommend removal of flaking paint to ceiling and redecoration with suitable moisture resistant paint.	2	
Floor	Non slip vinyl floor in poor condition.	1	Recommend replacement of flooring.	2

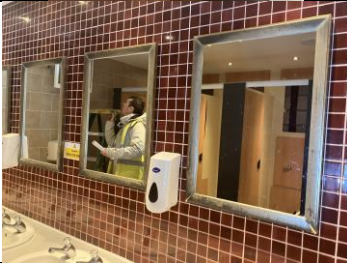
Walls	Full height tiling and IPS panels. Grouting to low levels heavily discoloured. Damaged sections to IPS panelling.	2	Recommend replacement of damaged IPS panels. Recommend renewal of grouting.	2

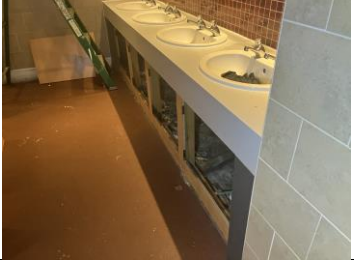
AREA	ISSUE	CONDITION	RECOMMENDATION	PRIORITY	PHOTO REF
Floor	Non slip vinyl floor. Flooring worn in areas and loose at junction to boxing.	2	Recommend replacement of flooring.	2

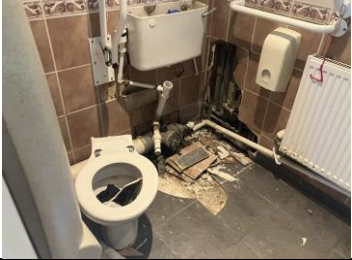
Floor	Tile floor, with matching tile upstand detail to wall. Tiles have been broken out to area underneath WC.	2	Recommend removal of existing tile and replacement.	2

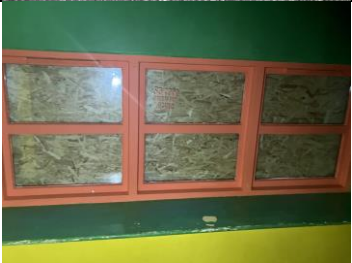
Windows	<p>Windows appear to be timber, fixed glazing.</p> <p>Windows have been decorated shut and boarded over externally.</p>	2	Recommend stripping of existing paintwork from windows and reinspect.	2
